Hospital Cafeteria Drain Sealed with Belzona 3121

ID: 10034

Industry: Buildings & Structures
Application: FPA-Floor Problem Areas
Substrate: Carbon steel
Products: Belzona 3121 (MR7)

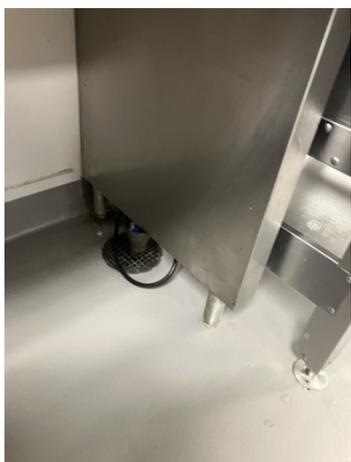
This multi story Hospital has an ice machine in the cafeteria that constantly drips into a floor drain. Over time the water has corroded the pipe and leaked into the office space at the level below. The water leaked onto computer equipment and personal belongings in the office area causing an unhappy office staff, staining on the ceiling with potential for mold, financial loss in damaged equipment, and safety concerns. This problem had been happening for months and finally needed to be stopped.

Ice machine with drain below

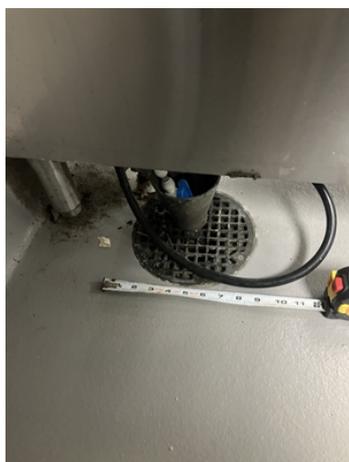
Drain close up image, with tape measure for scale

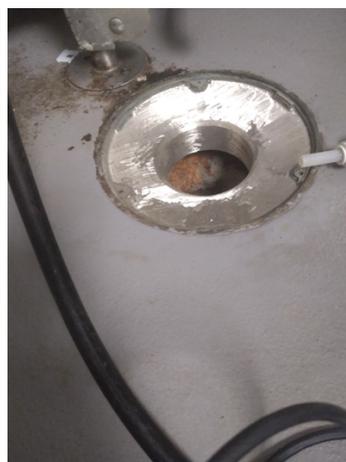
After surface prep was completed SSPC-SP11

Access was given and the drain was dry when we began. Our team taped off the application area, and began surface prep. We used grinders to abrade the metal drain and extend prep onto the concrete floor. Belzona 3121 was applied in a two coat system onto the drain to seal.

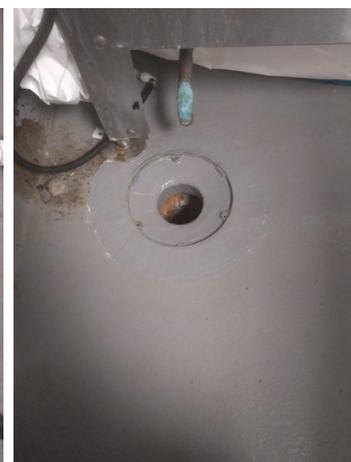
After application was completed with Belzona 3121
