# Hospital Cafeteria Drain Sealed with Belzona 3121

ID: 10034

Industry: Buildings & Structures  
Application: FPA-Floor Problem Areas  
Substrate: Carbon steel  
Products: Belzona 3121 (MR7)

Customer Location: Houston, TX  
Application Date: October 2025

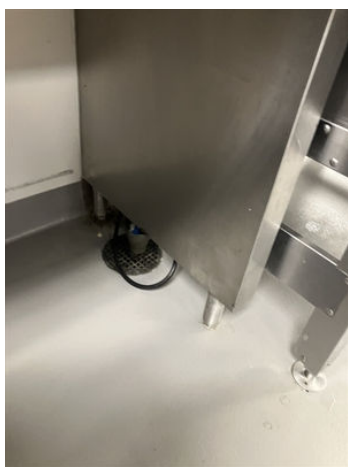
*This multi story Hospital has an ice machine in the cafeteria that constantly drips into a floor drain. Over time the water has corroded the pipe and leaked into the office space at the level below. The water leaked onto computer equipment and personal belongings in the office area causing an unhappy office staff, staining on the ceiling with potential for mold, financial loss in damaged equipment, and safety concerns. This problem had been happening for months and finally needed to be stopped.*

Ice machine with drain below

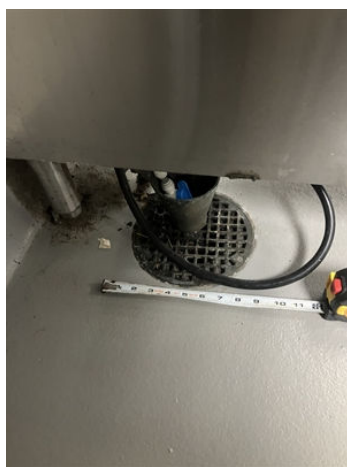
Drain close up image, with tape measure for scale

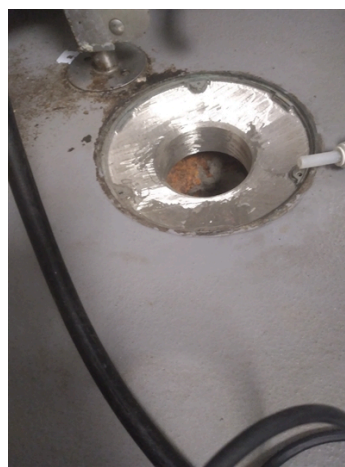
After surface prep was completed SSPC-SP11

Access was given and the drain was dry when we began. Our team taped off the application area, and began surface prep. We used grinders to abrade the metal drain and extend prep onto the concrete floor. Belzona 3121 was applied in a two coat system onto the drain to seal.

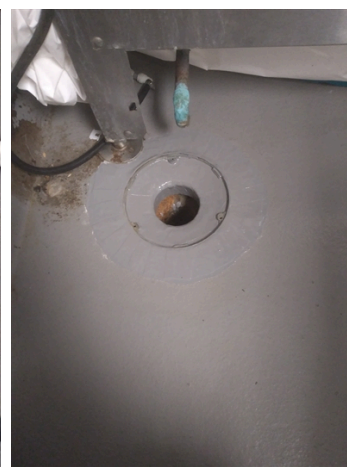
After application was completed with Belzona 3121
