Belzona solves a 20-year gutter issue at Premier League Football ground

ID: 10036

Customer Location: Nottingham
Application Date: July 2021

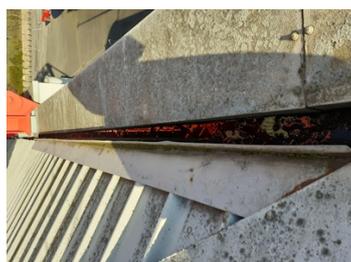
A 100m gutter had had been leaking for almost 20 years, having had many repair attempts over the time, none of which were successful. The leaking gutter would let large amounts of rain water onto the enclosed concourse below, making the surface slippery and dangerous to thousands of people when raining on match days.

Gutter above concourse, showing corrosion, failed joints and dropped edges.

Out of season, it was decided to over-clad the existing gutters with pre-fabricated steel gutter lining sheets. These would be bonded onto the existing substrate using Belzona surface tolerant epoxies, prior to overcoating with Belzona flexible membrane.

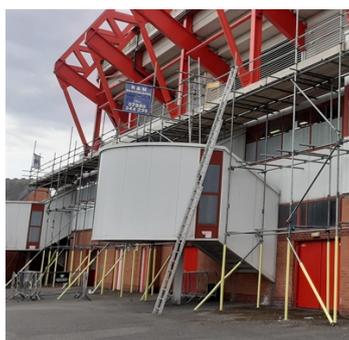
Scaffolding in place during repairs.

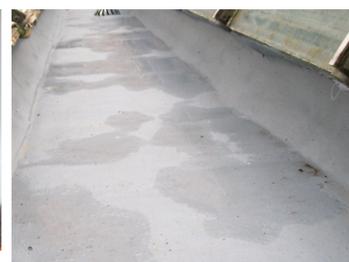
Completed relined and coating.

Pre-fabricated steel sheets were bonded over the original failed substrate using Belzona 1161.

The new steel was pre-conditioned using Belzona 3921.

2 coats of Belzona 3111 were then applied to completely protect the new steel.
