Belzona solves a 20-year gutter issue at Premier League Football ground

ID: 10036

Industry: Commercial Facilities
Application: RPA-Roof Problem Areas
Substrate: Carbon steel
Products: Belzona 1161 (Super UW-Metal), Belzona 3111 (Flexible Membrane), Belzona 3921 (GSC Surface Conditioner)

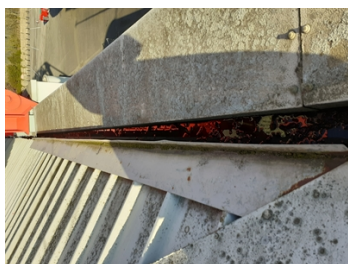
Gutter above concourse, showing corrosion, failed joints and dropped edges.

Out of season, it was decided to over-clad the existing gutters with pre-fabricated steel gutter lining sheets. These would be bonded onto the existing substrate using Belzona surface tolerant epoxies, prior to overcoating with Belzona flexible membrane.

Original substrate cleaned by high pressure water and left to dry.

Pre-fabricated steel sheets were bonded over the original failed substrate using Belzona 1161.

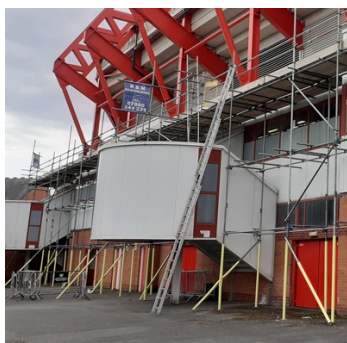
Scaffolding in place during repairs.

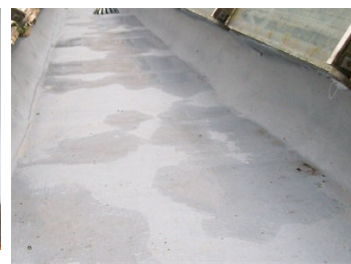
Completed reline and coating.

The new steel was pre-conditioned using Belzona 3921.

2 coats of Belzona 3111 were then applied to completely protect the new steel.

The water ingress was stopped immediately, much to the relief of the operations manager and ground staff. The concourse remains dry and water free.
