# Stairwell saved by Belzona membrane

ID: 10037

Industry: Commercial Facilities  
Application: RPA-Roof Problem Areas  
Substrate: Other  
Products: Belzona 3131 (WG Membrane), Belzona 3921 (GSC Surface Conditioner)

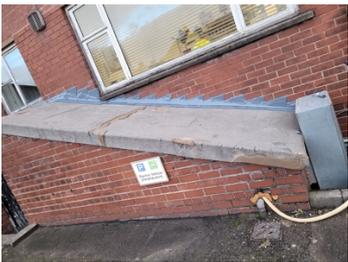
The mineral felt had disbonded from the base substrate and the lead flashings had detached from the wall on the slanting roof area of a stairwell

Slanting roof area showing failures to existing waterproofing

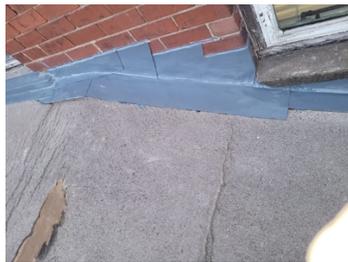
Stripe coat of Belzona 3131 applied following conditioning of lead using Belzona 3921

Belzona 3921 GSC was applied to the lead areas with no conditioner necessary for the main mineral felt areas

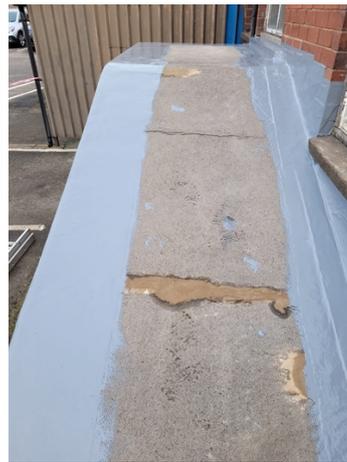
Edges complete and awaiting main membrane application

2 coats of Belzona 3131 Winter Grade were applied complete with Belzona 9361 reinforcing sheet

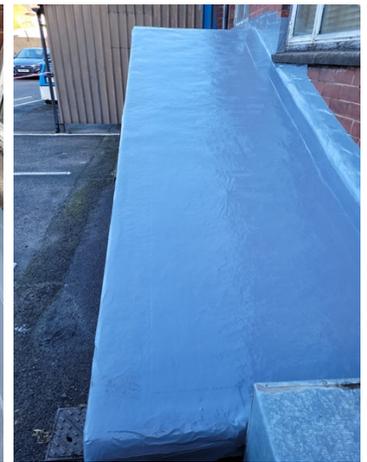
Completed works
