# Relining to rear gutter of High Street premises with Belzona

ID: 10038

Industry: Commercial Facilities  
Application: RPA-Roof Problem Areas  
Substrate: Carbon steel  
Products: Belzona 3131 (WG Membrane), Belzona 3921 (GSC Surface Conditioner)

Customer Location: Ilkeston  
Application Date: November 2023

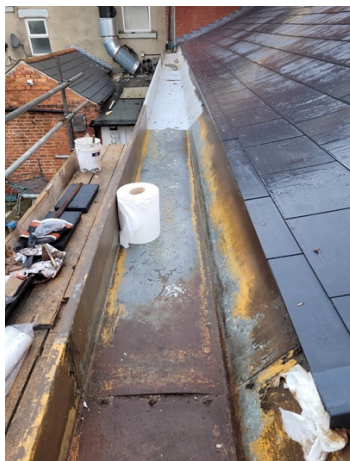
Gutter cleaned and prepared using High Pressure jetting equipment.

The gutter was cleared of dirt, mud and debris prior to being high pressure washed.

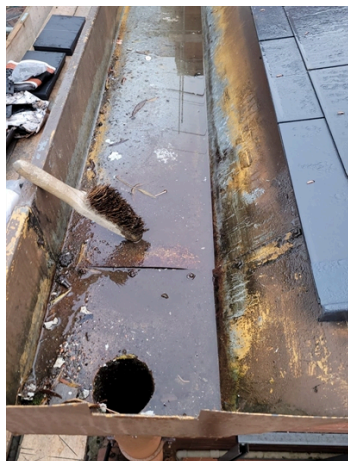
Particular attention was paid to the lower end of the gutter where the downpipe was situated.

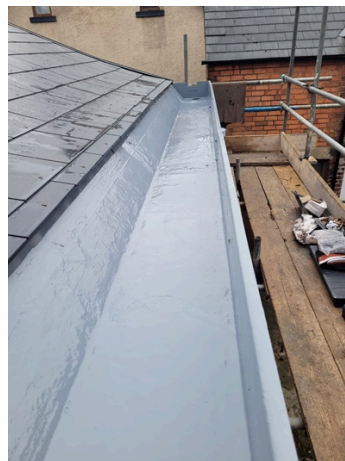
Application of Belzona 3131 system completed, returning the gutter to watertight and alleviating the issues to the shop owners.

2 coats of Belzona 3131 complete with 9361 reinforcing sheet were applied to complete the works.

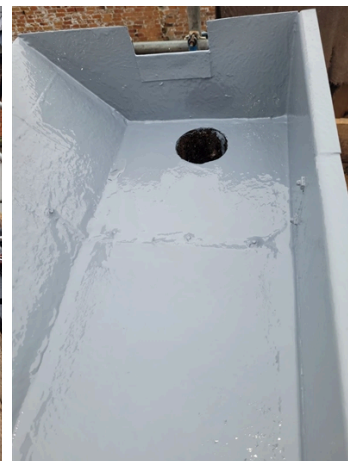
Completed downpipe end, ensuring that all joints, welds and seams were perfectly encapsulated.
