# Relining to rear gutter of High Street premises with Belzona

ID: 10038

Application: RPA-Roof Problem Areas

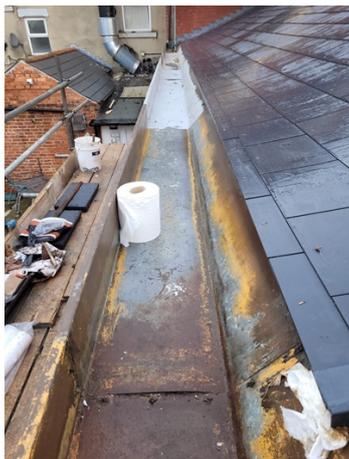
Gutter cleaned and prepared using High Pressure jetting equipment.

The gutter was cleared of dirt, mud and debris prior to being high pressure washed.

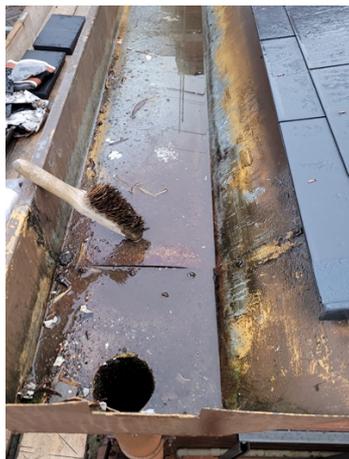
Particular attention was paid to the lower end of the gutter where the downpipe was situated.

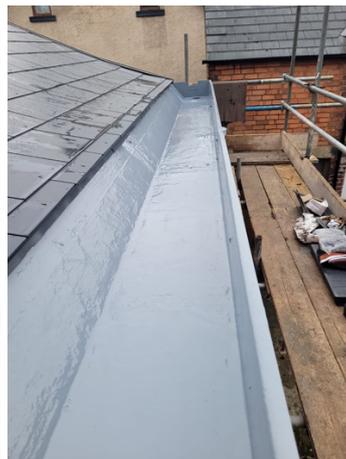
Application of Belzona 3131 system completed, returning the gutter to watertight and alleviating the issues to the shop owners.

Belzona 3921 GSC was applied to the entire area, preparing the steel substrate for the Belzona Winter grade system.

2 coats of Belzona 3131 complete with 9361 reinforcing sheet were applied to complete the works.

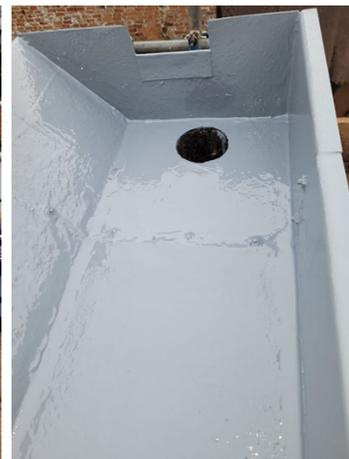
Completed downpipe end, ensuring that all joints, welds and seams were perfectly encapsulated.
