A GOOD NIGHT WITH BELZONA

ID: 1004

Industry: *Buildings & Structures*
Application: *GSS-Gaskets, Seals and Shims*
Substrate: *Cast iron*
Products: *Belzona® 1111 (Super Metal)*

Customer Location: *Local municipality, Slovenia*
Application Date: *July 2007*

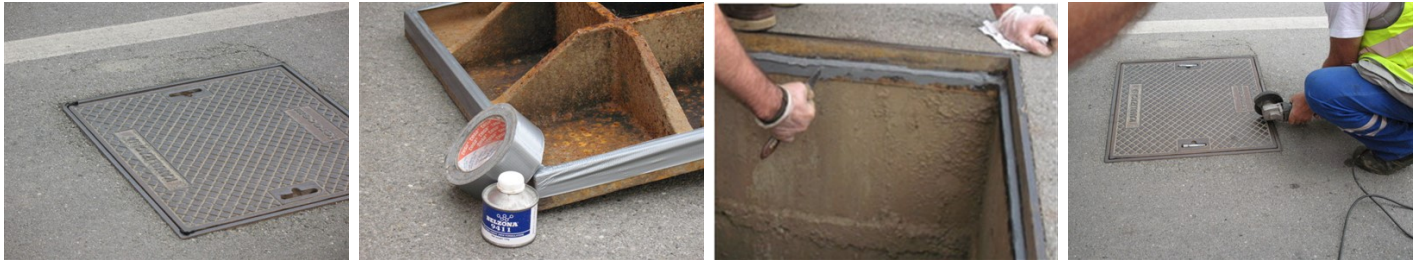
Photograph Descriptions

Manholes on the street were causing a lot of noise due to uneven cover seat. Local people call them "Singing Covers".

* Manhole , * Applying Duct tape and Belzona® 9411 , * Rebuilding manhole cover seat with Belzona® 1111 , * Manhole in place and position marked ,

The manhole seats were roughened and then degreased.

Cover plate ends were protected with Duct tape and Belzona® 9411. Belzona® 1111 was used to rebuild the manhole cover seat in accordance with Belzona Know-How System Leaflet GSS-8.

Belzona® 1111 made a cost effective solution and a perfect fit of the manhole cover in its seat eliminating noise.
