Belzona protects flare stack vessels for large oil refinery site

ID: 10042

Customer Location: Stanlow, UK
Application Date: September 2025

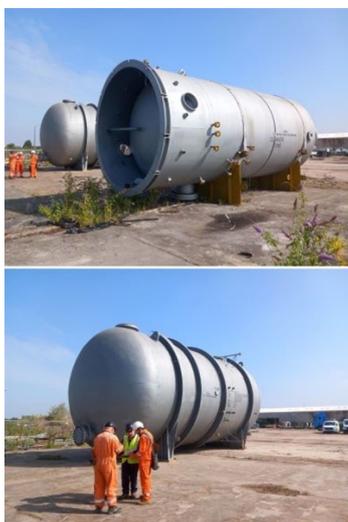
Showing the exterior of both vessels. An idea of size of vessels can be judged by the staff in the image. 350+ sqm internal walls across both vessels.

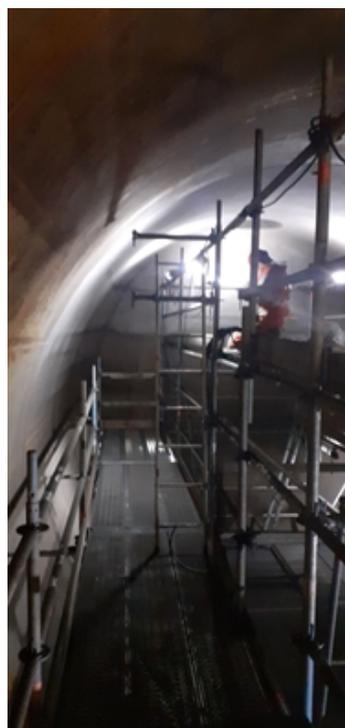
Internal of smaller vessel, showing scaffolding for top half of the vessel. The smaller vessel had internal fixtures that also required protective coating.

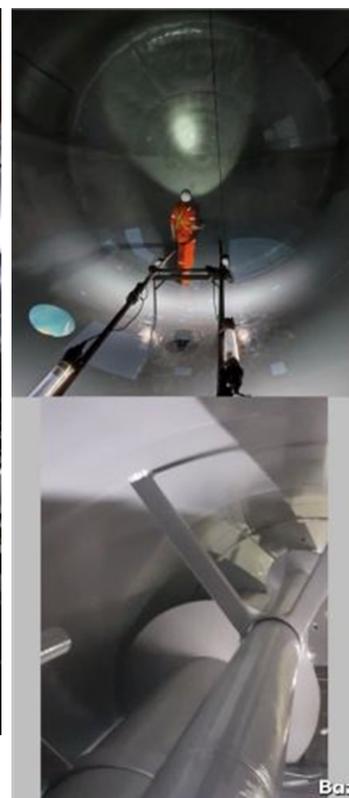
Internal of larger vessel, showing 3 tiered scaffolding for access to all levels. This image shows a part blasted and prepared surface, ready for spray application.

Grit blasting of all areas to be coated was carried out by a third party. The Belzona 1391S was applied via a plural spray technique. Belzona 1391T was applied via Belzona applicators and brush techniques on the weld areas and the areas where spraying could not be carried out. Belzona 1511 nozzle inserts were used for 18 nozzles spread across the two vessels, and a Belzona 1391T coating was applied along with the nozzle inserts.
