Sloping walkway get's Belzona "Surefoot" system

ID: 10046

Industry: *General Industry* Customer Location: *Workshop*
Application: *FPA-Floor Problem Areas* Application Date: *May 2022*
Substrate: *Concrete*
Products: *Belzona 5231 (SG Laminate), Belzona 9221 (Surefoot Aggregate White)*

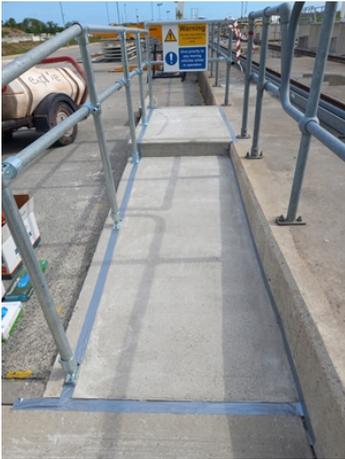
A small sloping external walkway had proven hazardous during the previous winter and it was decided to improve the basic concrete surface using Belzona products.

Walkway prior to commencement

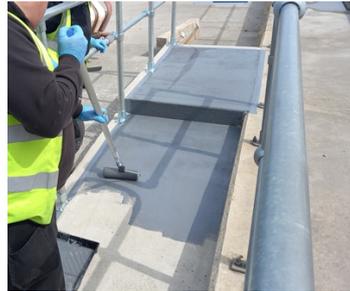
Applying Belzona 5231

The Belzona 5231 was mixed and the first coat applied, after which around 2Kg per m2 of Belzona 9221 Surefoot aggregate was scattered into the wet surface.

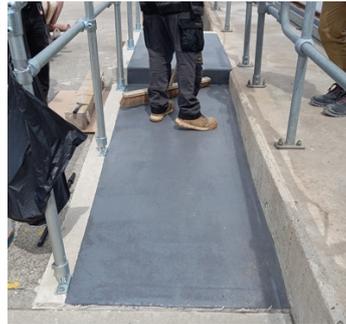
Works advancing

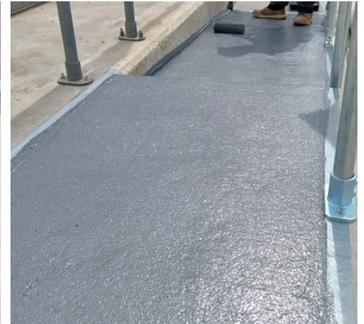
Completing the application

A further coat of Belzona 5231, being a different shade, was applied over the top of this to completely encapsulate the surface, leaving a safe, non-slip durable finish.
