# Belzona Saves Bow Thruster Tunnel from Electrolysis

ID: 10047

Industry: *Marine*  
Application: *SOS-Ships and Offshore Structures*

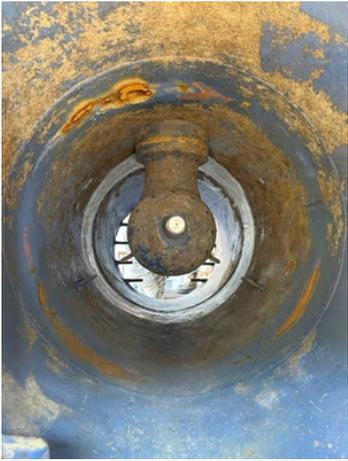
*Customer had a large government ferry 1-yr old that was suffering from electrolysis in the bow thruster tunnel.*

Bow thruster tunnel suffering from pitting due to electrolysis.

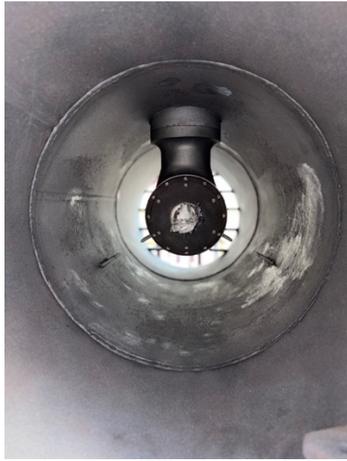
Bow thruster tunnel blasted to required SSPC-SP10.

Tunnel was blasted to SSPC-SP10 requirements. Tunnel was then cleaned with Belzona 9111 and allowed to dry. Belzona 1311 was then hand applied with applicators and short bristle brushes to fill in all pitting. Belzona 1321 1st coat was applied gray and then followed by 2nd coat of blue.

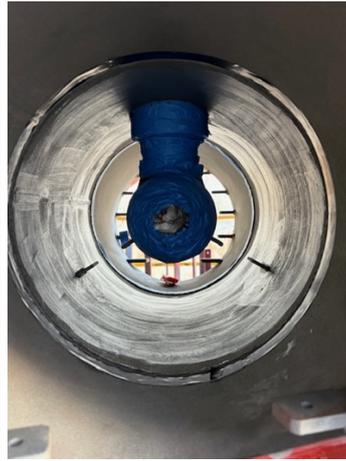
Belzona 1311 used to fill all pitting in tunnel.

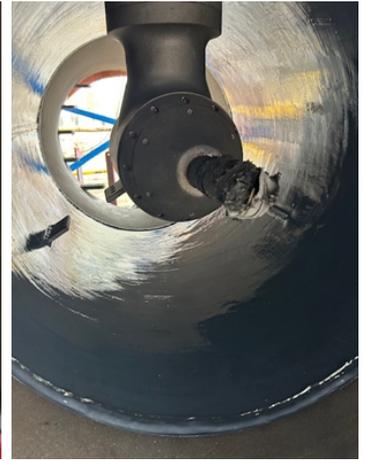
Job completed after 2nd coat of Belzona 1321 coating.
