Shaft Rebuild – Machine Down Repair

ID: 10050

Industry: Power
Application: MPT-Mechanical Power Transmission

Substrate: Carbon steel
Products: Belzona 1161 (Super UW-Metal)

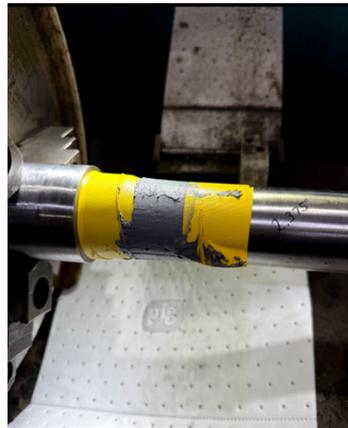
Application of Belzona 1161 (Super UW-Metal) using a plastic former to rebuild the eroded area and restore original shaft dimensions.

A forming technique was used by installing a plastic former around the damaged section, and Belzona 1161 was mixed and applied to rebuild the eroded profile.

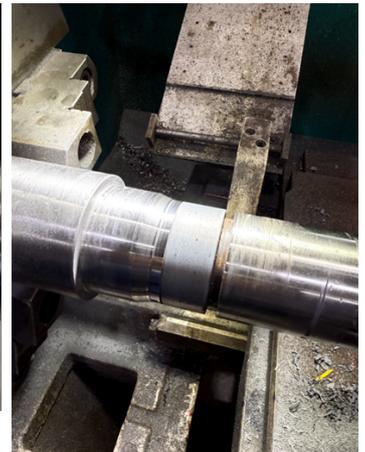
Final result after machining. The shaft was rebuilt with Belzona 1161 and restored to its original diameter and smooth finish.

After full curing, the former was removed and the shaft was machined back to original dimensions, restoring proper fit and alignment.
