Passenger ferry engine cylinder repair

ID: 10053

Industry: Marine
Application: ENC-Engines and Casings
Substrate: Carbon steel
Products: Belzona 1311 (Ceramic R-Metal)

Customer Location: Scotland, UK
Application Date: January 2021

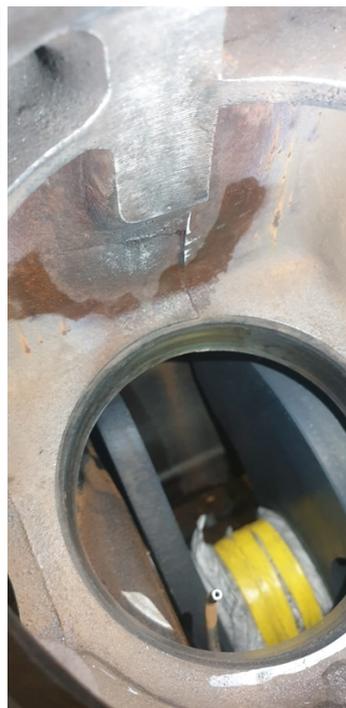
An engine used to run one of the bow thrusters was found to have damage within its engine cylinders. This was suspected to be caused by cavitation between the wall & the cylinder liners.

Vessel docked during overhaul

Damaged area identified

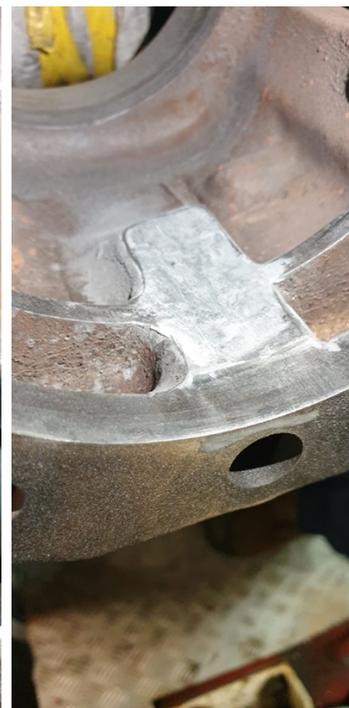
Surface preparation

Belzona 1311 applied & then machined flat with the surrounding metal

The identified areas were ground out using an angle grinder. Belzona 1311 was then applied 'proud' of the lost metal. Once the product had reached its initial cure stage it was then machined down flat with the metal.
