Sealing pipes around a chemical sump

ID: 10054

Application: TCC-Tanks and Chemical Containment Areas

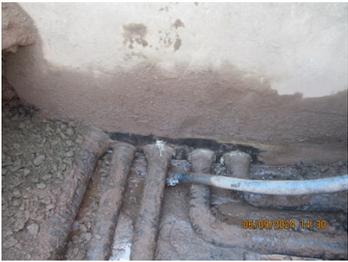
A series of pipes entering a chemical sump were found to be a leak path for water to enter the sump. This leak path needed to be stopped as the chemicals within the sump could react violently with water

Pipe excavation

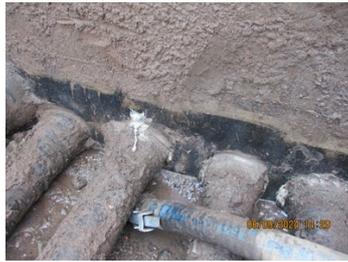
Close up showing leak path

Mortar repairs had been attempted in the past. They were found to be ineffective due to their porous nature & poor adhesion to existing concrete. The Belzona solution was selected due to its impermeable nature & excellent adhesion to different substrates.

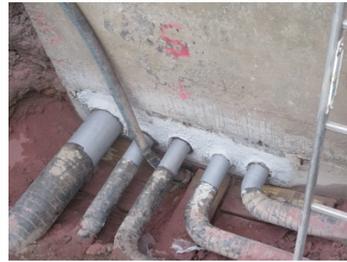
Surface preparation

The pipes & concrete wall were grit blasted. Belzona 4911 TX Conditioner was applied & then Belzona 4111 was built up around the pipes to seal any potential leak paths

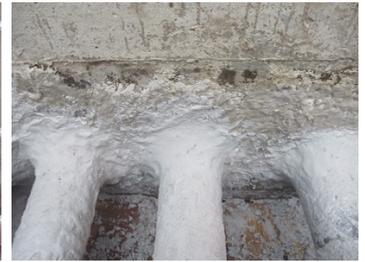
Belzona 4911 & Belzona 4111 applied
