Plastic tank pipe repairs

ID: 10055

Industry: Power
Application: TCC-Tanks and Chemical Containment Areas
Substrate: PVC
Products: Belzona 1221 (Super E-Metal), Belzona 1981 (SuperWrap II)

Customer Location: Scotland, UK
Application Date: May 2023

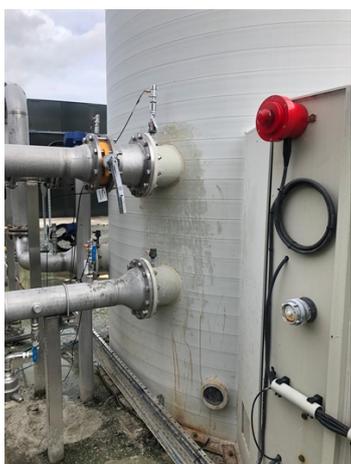
A plastic tank had developed several cracks around pipes. A replacement was planned but to get production through to that point a temporary fix was requested.

Leaking area

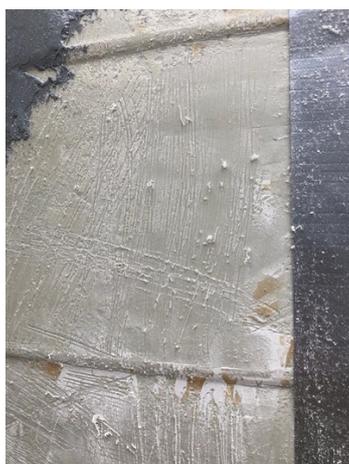
Surface preparation on the plastic tank

A repair was developed using roughening brushes on the plastic substrate & Belzona 1221 to yield best possible adhesion.

The area around the crack was roughened, Belzona 1221 applied. Belzona Superwrap 2 was then applied on top to impart more flexural strength to the repair.

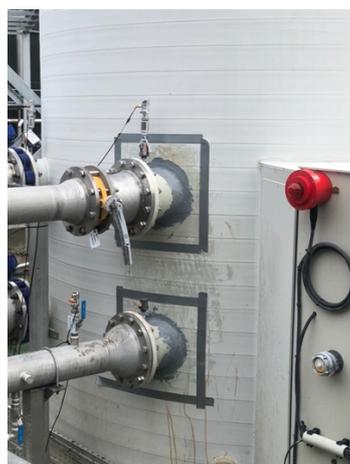
Belzona 1221 applied

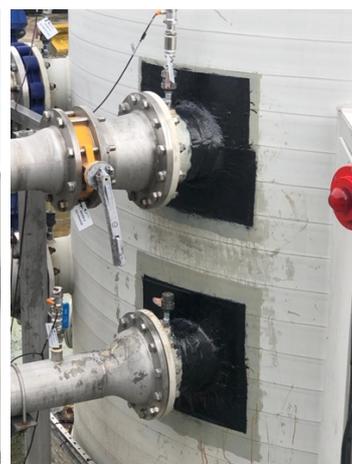
Belzona SuperWrap II system applied

Using this method got the tanks back into service with minimal disruption to surrounding production
