# BELZONA GIVES OLD PUMP NEW LEASE OF LIFE

Customer Location: Coal-fired power plant, Croatia

Application: CEP-Centrifugal Pumps

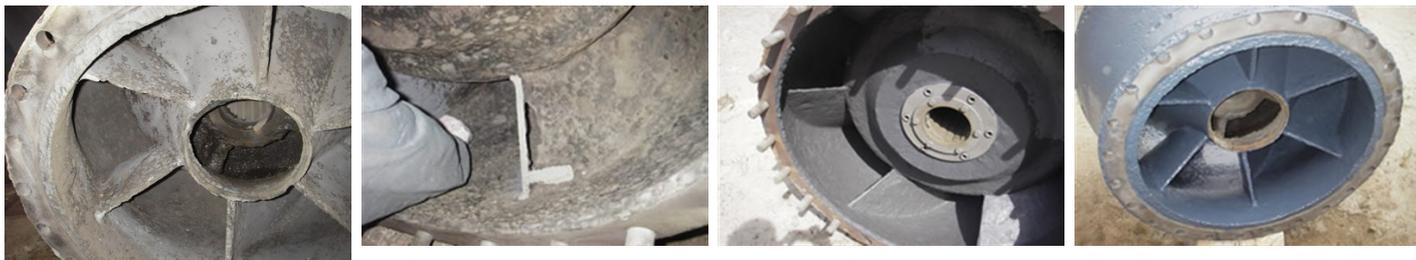
Deterioration due to bimetallic corrosion and sea water erosion.

\* Damaged seawater pump , \* Applying Belzona® 1311 , \* Belzona® 1311 application complete , \* Belzona® 1321 applied ,

Application was carried out in accordance with Belzona Know-How System leaflets CEP-3 & -5.

Due to the pump's condition, a new pump was considered but Belzona application proved to be a long term cost effective alternative.
