Concrete repairs to heavy manufacturing floor

ID: 10074

Industry: Heating, Ventilation & Air Conditioning
 Application: FPA-Floor Problem Areas
 Substrate: Concrete
 Products: Belzona 4131 (Magma-Screed), Belzona 4911 (Magma TX Conditioner)

Customer Location: Doncaster
 Application Date: March 2022

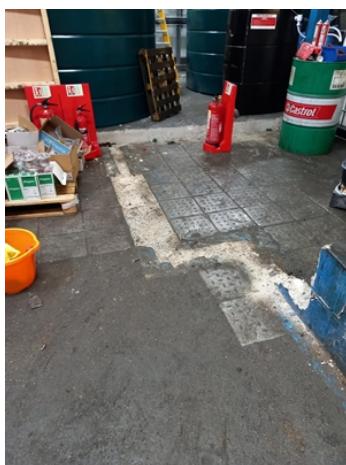
Areas of a heavy industrial floor were compromised and had started to break up, some of which had been repaired previously, though these repairs had failed

Showing one of the heavily damaged areas

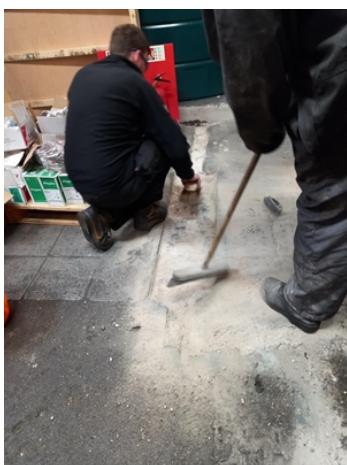
Cleaning area prior to application

Clean all area

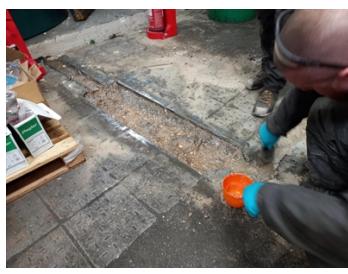
Application of Belzona 4911 TX Conditioner

Mix and apply Belzona 4911 TX conditioner

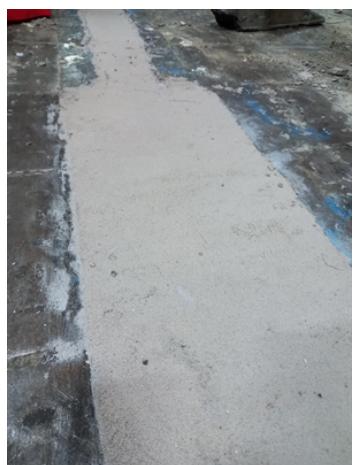
Completed application using Belzona 4131

Mix and apply Belzona 4131

The local Belzona ASR supported to application and trained the in-house colleagues on the proper procedure to effect a concrete repair. The site was visited earlier this year (2025) and found to be in excellent order
