Steel Mill Sluice Repair by Belzona Composite Repair System in New Zealand

Industry: Steel & Metal Processing
Application: SHM-Solids Handling Machinery

Customer Location: Glenbrook, New Zealand
Application Date: November 2025

Substrate: Concrete
Products: Belzona 1321 (Ceramic S-Metal), Belzona 1812 (Ceramic Carbide FP), Belzona 4151 (Magma-Quartz Resin)

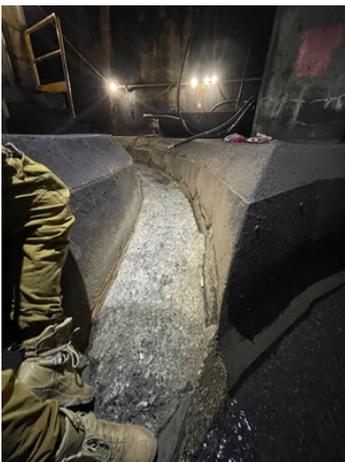
The condition of the concrete after the sluice had been drained and cleared of beards and grit.

The sluice is located directly beneath the conveyor along which the steel slab moves as it leaves the ovens during hot rolling. During this process, impurities known as beards flake off and fall into the sluice, where they are carried away. These beards, along with smaller particulates, are extremely abrasive and gradually wear grooves into the sluice walls. These grooves trap the beards, creating dams that block the flow.

1. The channel was dammed off, drained, and cleared of all debris. Five lineal meters were then grit-blasted in preparation for the application.
2. Belzona 4151 (Magma-Quartz Resin) was mixed with quartz sand in a resin-rich mixture and applied to the channel to restore its original geometry and create a smooth surface for the alumina tile system.

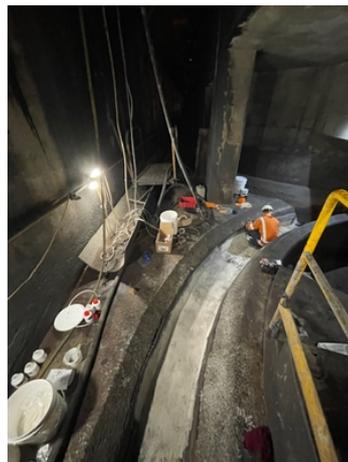
The channel was rebuilt using Belzona 4151 (Magma Quartz Resins) and locally sourced fine quartz sand and then lined with alumina tiles using Belzona 1321 (Ceramic S-Metal) as the adhesive.

3. Belzona 1321 (Ceramic S-Metal) was selected as the adhesive and applied to an average wet film thickness of 1000 microns.
4. The tile sheets were pressed into the Belzona 1321 until the entire 5-meter length was filled.

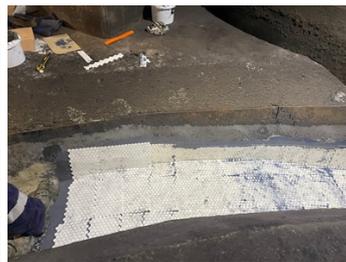
Once the Belzona 1321 (Ceramic S-Metal) had cured, the fabric backing was removed, and the area was frost-blasted in preparation for grouting with Belzona 1812 (Ceramic Carbide FP).

5. Once cured, the fabric backing and any loose tiles were removed. The area was then frost-blasted and cleaned with compressed air.
6. Belzona 1812 (Ceramic Carbide FP) was applied as a grout and used to create transitional areas between the tile sheets and the channel to prevent future beards from jamming or cutting under the tiles.

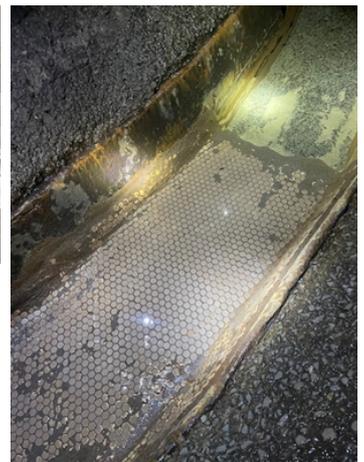
The Belzona system exhibits virtually no wear after 3 months of service in this particularly aggressive environment and the customer has now asked us to complete an additional 20 meters of sluice for them.

After three months of service, the Belzona repair system has shown virtually no signs of wear. The client has subsequently approved extension of the lining to an additional 20 meters of sluice.
