# Belzona Elastomers for Fender Repair in New Zealand

ID: 10083

Customer Location: Auckland Port  
Application Date: July 2024

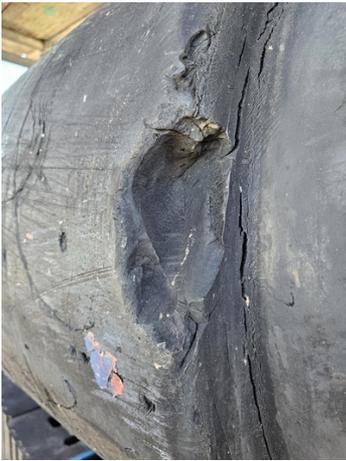
Deep gouges and loss of the original substrate was causing mooring ropes to catch and cause further damage to the fender of a tugboat. Replacement would involve a large amount of time and considerable cost

Large tears and gouges reduced the efficacy of the Fender and caused ropes to become caught
