Belzona Repairs Staircase of 79-Meter-Diameter Crude Oil Storage Tank

ID: 10087

Industry: Oil & Gas
 Application: TCC-Tanks and Chemical Containment Areas
 Substrate: Carbon steel
 Products: Belzona 1161 (Super UW-Metal), Belzona 9111 (Cleaner Degreaser)

Customer Location: Paradip, India
 Application Date: April 2015

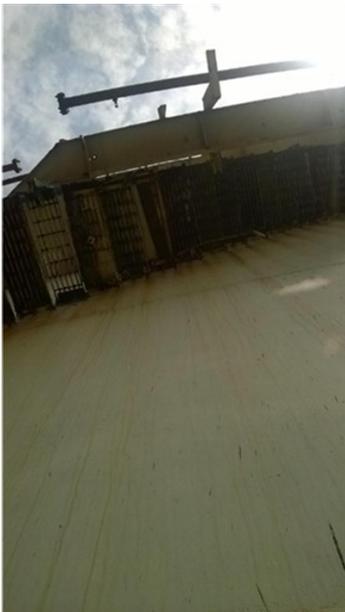
The staircase of the 79-meter-diameter crude oil storage tank was damaged.

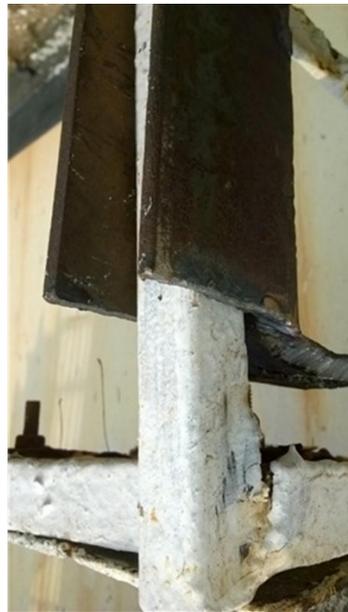
The stair fixing arrangement was carefully designed to ensure safety and structural stability.

1. Mechanical cleaning using non-sparking tools to remove loose corrosion and contaminants.
2. Degreasing the application surface with Belzona 9111 Cleaner/Degreaser.
3. Repairing the damaged gratings and repositioning the dislodged stairs, which were structurally bonded to the tank shell using Belzona 1161 Super UW Metal.
4. Allowing the repair to cure for 24 hours.

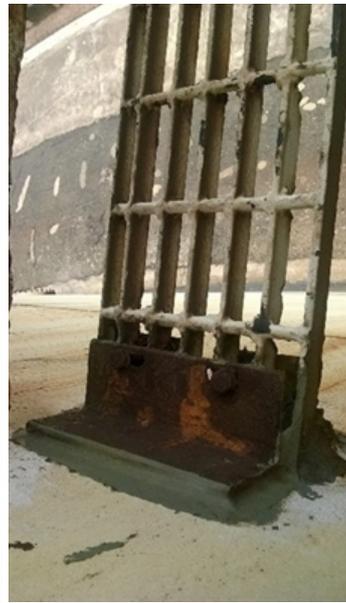
The grating stair was securely fixed to the tank shell.

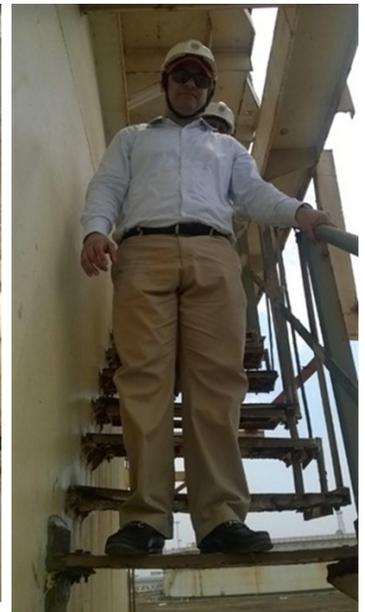
The stairs were fixed and tested with a human trial.

The repair was continuously monitored until November 2025, and the stairs have been performing flawlessly for over 10 years.
