Belzona Saves Automobile Plant Shutdown by Repairing Damaged Fan Shaft In Situ within 20 hours

ID: 10088

Industry: General Industry
Application: MPT-Mechanical Power Transmission

Substrate: Cast Iron
Products: Belzona 1111 (Super Metal), Belzona 9111 (Cleaner Degreaser), Belzona 9411 (Release Agent)

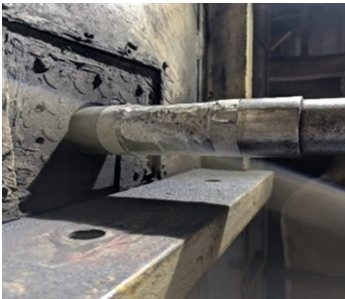
The fan shaft of the air supply machine was prepared manually.

1. Burn the damaged area of the shaft using an oxy-acetylene flame.

2. Clean the area with Belzona 9111 Cleaner/Degreaser.
3. Roughen the surface using a conical Totem cutter.
4. Clean the surface again with Belzona 9111 Cleaner/Degreaser.
5. Apply Belzona 9411 (Release Agent) on the prefabricated form/template, including all bolts, and allow it to dry.
6. Apply Belzona 1111 (Super Metal) to the prepared area of the shaft, and also apply a layer on the inner side of the form/template.
7. Fix the form/template onto the shaft, insert the bolts, and tighten to the desired dimension.

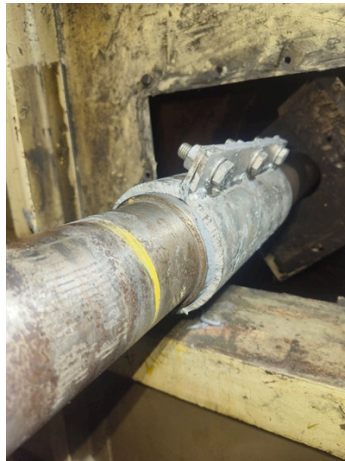
Applied Belzona 1111 (Super Metal) using a template with Belzona 9411 release agent.

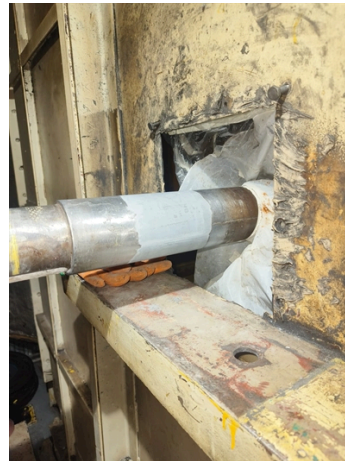
The application was completed to the desired dimensions.

Remove the form/template after 4 hours and finish the surface using smooth emery paper.

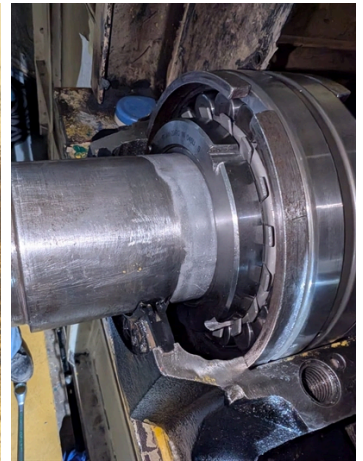
The bearing was fitted onto the repaired area.

Install the bearing onto the repaired area.
