# Belzona Saves Automobile Plant Shutdown by Repairing Damaged Fan Shaft In Situ within 20 hours

ID: 10088

Application: MPT-Mechanical Power Transmission

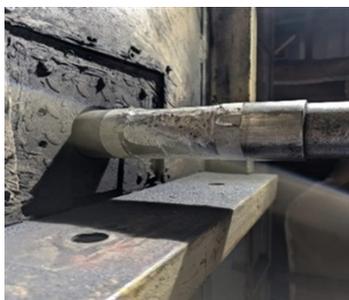
The fan shaft of the air supply machine was prepared manually.

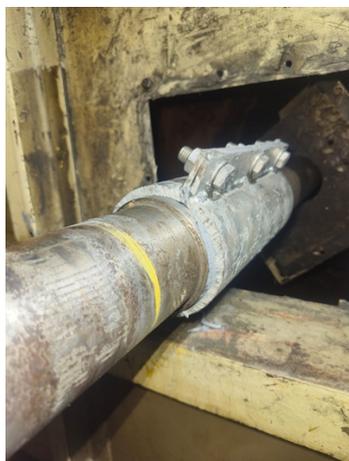
Applied Belzona 1111 (Super Metal) using a template with Belzona 9411 release agent.

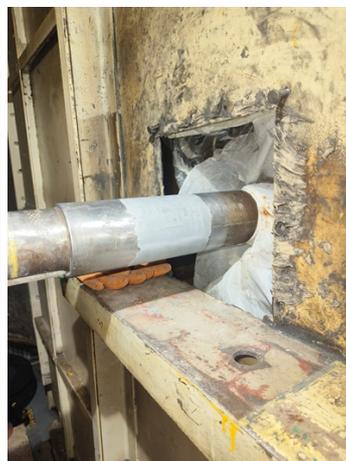
The application was completed to the desired dimensions.

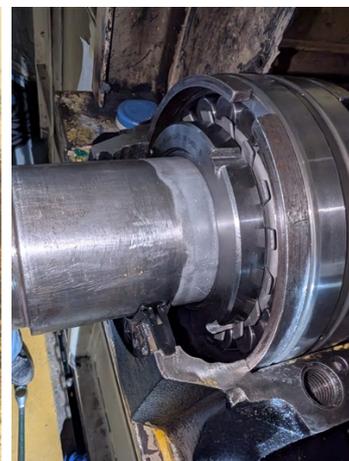
The bearing was fitted onto the repaired area.
