Belzona cooling tower basin repair

ID: 10091

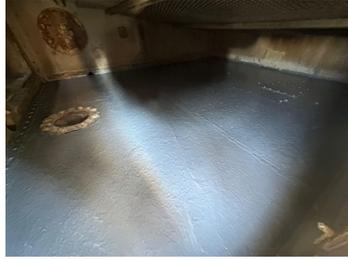
Cooling tower basin was experiencing deterioration and required a face lift.

Basin before repair

Power tool cleaning was carried out on the surface before the pitting was covered with Belzona 1161. Two coats of Belzona 5831 was then applied afterwards.
