Mitigating the abrasive effect of ash with Belzona lining

ID: 10092

Application: SHM-Solids Handling Machinery

Products: Belzona 1812 (Ceramic Carbide FP)

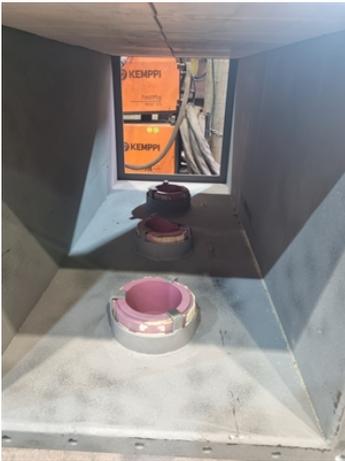
Grit blasted element before application.

Application was carried out in accordance with Belzona Know-How System Leaflet SHM-13. Surfaces were grit blasted and degreased with acetone. Belzona 1812 was applied to all internal surfaces of the element using Belzona application tools.

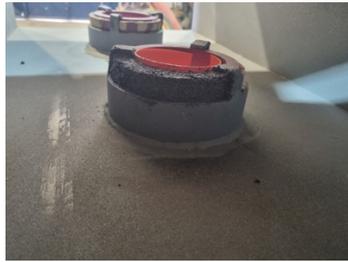
Application of Belzona 1812 on side openings, using mixing bowl as a former.

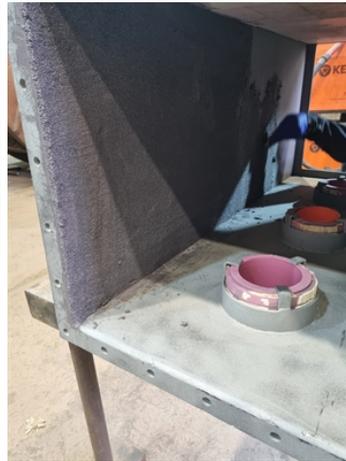
Application of Belzona 1812 on internal surfaces.

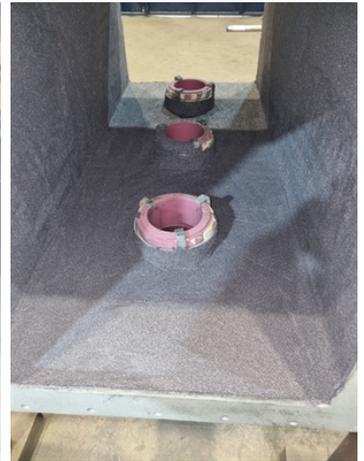
Application completed.
