# Belzona Protection of a Cooling Water Seawater Line in a Saudi Arabian Power Plant

ID: 10093

Industry: Power  
 Application: VPF-Valves, Pipes and Fittings  
 Substrate: Carbon steel  
 Products: Belzona 1311 (Ceramic R-Metal), Belzona 1321 (Ceramic S-Metal), Belzona 5811 (Immersion Grade)

Customer Location: Saudi Arabia  
 Application Date: March 2023

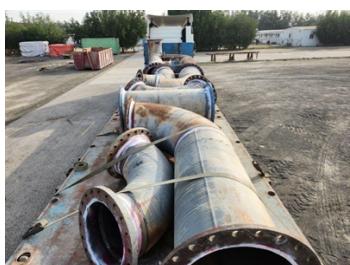
The seawater piping in the power plant exhibited significant internal degradation, characterized by corrosion, erosion, and substantial metal loss. In addition to the internal damage, the piping was also subjected to external corrosion due to persistent moisture exposure at its installation location.

General overview of the seawater spools.

The spools were abrasive grit blasted, and the welds and areas of significant metal loss were built up and faired using Belzona 1311 (Ceramic R-Metal).

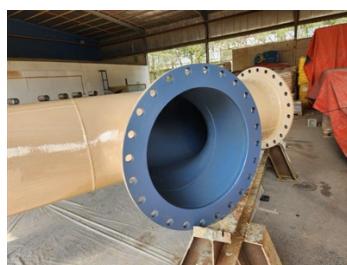
Application of Belzona 1321 (Ceramic S-Metal), an erosion-corrosion resistant lining, applied internally.

1. To restore and protect the piping, the surfaces were first prepared by grit blasting and cleaning to achieve the required standard of cleanliness and roughness, followed by thorough degreasing to ensure they were free from contaminants.
2. Belzona 1311 (Ceramic R-Metal) was then applied to rebuild and restore areas where significant metal loss had occurred, reinstating the original profile and structural integrity.
3. Once the rebuilding was complete, 1321 (Ceramic S-Metal) was applied as an internal lining to provide long-term resistance against seawater corrosion and erosion, ensuring durability under continuous flow conditions.
4. For external protection, Belzona 5811 (Immersion Grade) was applied in two coats to create a moisture-resistant barrier capable of withstanding the harsh marine atmosphere.
