# 20" Crude Oil Line Repair Using Belzona Non-Compliant SuperWrap II

ID: 10094

Customer Location: Al Jhaffi  
 Application Date: July 2025

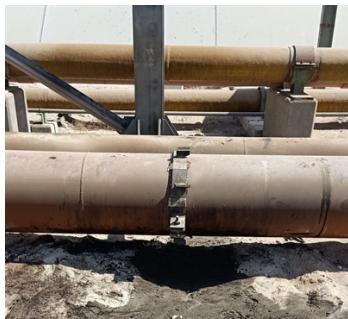
The 20" pipe was clamped by the customer due to severe leakage.

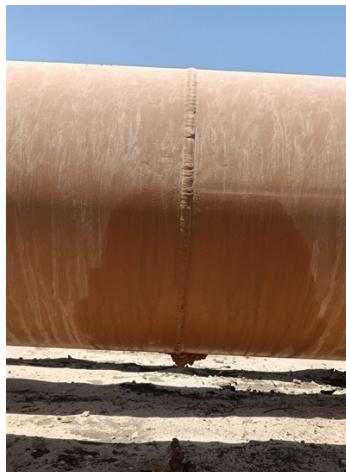
Second Location

A 20-inch crude oil pipeline operating at ambient temperature was found to have two 10 mm through-wall defects at the 6 o'clock position, one of which was actively leaking. The line was shut down due to safety concerns; however, heavy oil sludge within the pipeline continued to melt and drip under high ambient temperatures, making leakage control difficult.

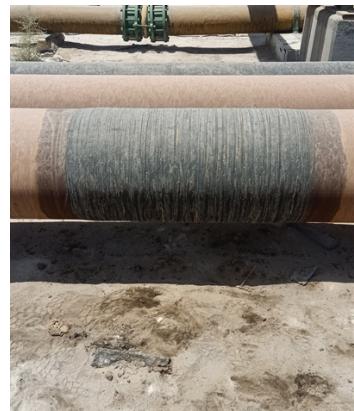
After successful application of Belzona SuperWrap II (3 wraps) No leaks were observed in the Belzona SuperWrap II repair after four months of service.

Belzona surface-tolerant materials were first applied to seal the active leak and stabilize the affected area. Once the LEL level reached zero, surface preparation was carried out by grit blasting to Sa 2½, achieving a minimum 75-micron surface profile. A non-compliant Belzona SuperWrap II system, using Belzona 1983 resin and Belzona 9381 carbon-glass fiber reinforcement, was then applied in three wraps. The wrap was consolidated with Belzona 9382 release film and allowed to cure before the film was removed.
