# Belzona Brings Split Case Pump Back to Life

ID: 10097

Application: CEP-Centrifugal Pumps

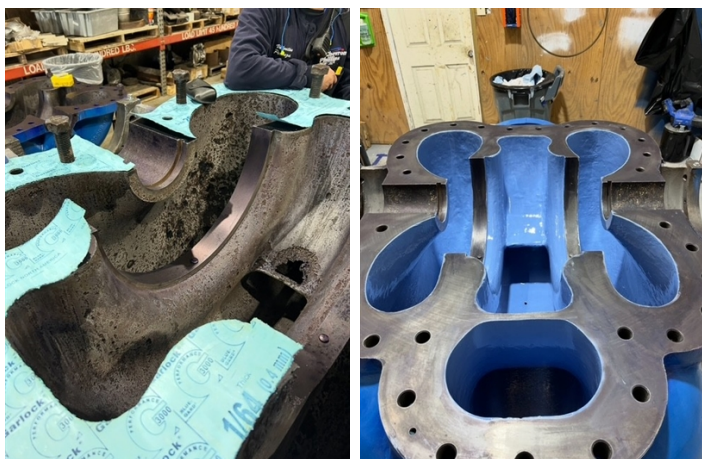
*This cooling water pump had severe pitting and the customer wanted to replace it, however the lead time was over 6 months. I talked to the customer about letting us blast, pitfill and coat this one. They were in a bind because they only had a 5 day window to get this pump back in service or they would have to shut down the plant.*

Pump before the application. Pump after 1121 and 1341.

We had the pump delivered to our shop and blasted it to bare metal. Used 1121 to fill the pitting and then 2 coats of 1341
