Belzona Seals Concrete Leak in External Stairwell to Protect Hospital

ID: 10098

Application: WPA-Wall Problem Areas

Substrate: Concrete

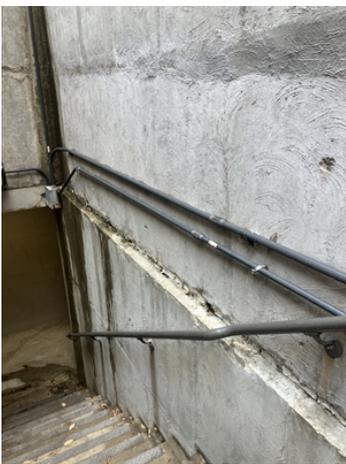
This image shows the leak externally in the vertical and horizontal joint of the wall.

1. Surface prep was done by using a handheld grinder with a 7" turbo cup diamond grinding disk attachment to roughen the surface.
2. Belzona 9611 was used to plug leaking defects in the vertical joint.
3. Belzona 4911 conditioner was applied on the horizontal joint.

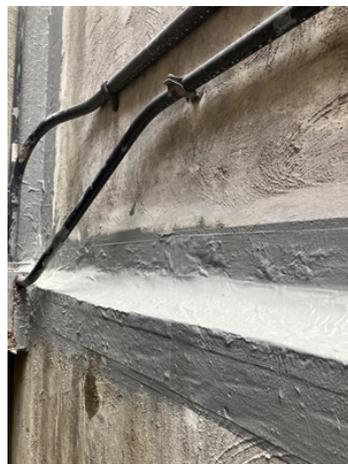
This is a close up on the 3121/9331 repair on the horizontal and vertical joints, after the job was completed.

5. Belzona 3121 and 9331 were applied to composite patch the vertical and horizontal joints.

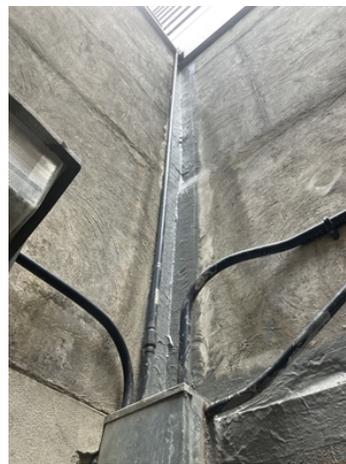
Close up on the vertical joint after the application was completed.

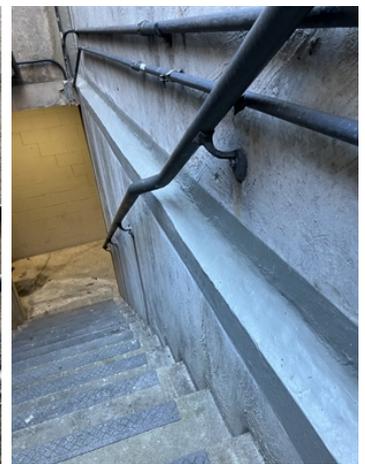
Close up image of the repair in service about 1 year later. Performing well, no leaks!
