# Belzona Coatings Restore Seven Chillers at Global HQ of Oil and Gas Company

ID: 10099

Industry: Commercial Facilities  
Application: HEX-Heat Exchangers  
Substrate: Carbon steel  
Products: Belzona 1121 (Super XL-Metal), Belzona 1331

Customer Location: Houston, TX  
Application Date: November 2025

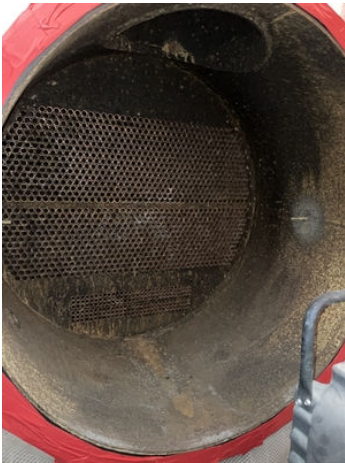
Condition of the asset before Belzona was applied.

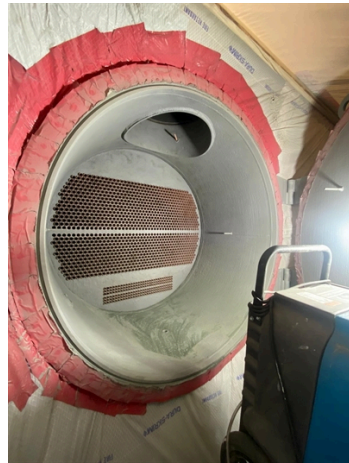
After the abrasive blasting was completed, SSPC-SP10.

1. The asset was opened, drained and dried using fans.
2. A containment was built by screwing together a wood frame and taping sheets of poly around it, to make an air tight enclosure.
3. Corks were used to plug the tubes.
4. Abrasive blasting was completed to achieve a minimum 3mil profile, SSPC-SP10.
5. Belzona 1121 was used to pit fill as needed.
6. Belzona 1331 was applied in a two coat system over the entire application area.

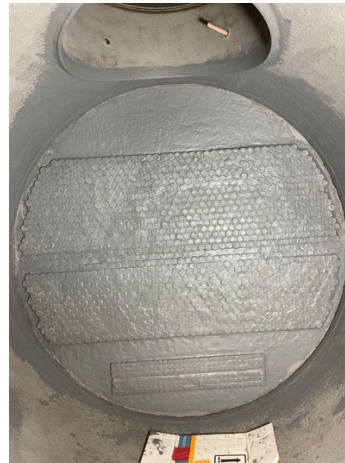
After Belzona 1121 was used to pit fill the tube sheet.
