Belzona Coatings Restore Seven Chillers at Global HQ of Oil and Gas Company

ID: 10099

Industry: Commercial Facilities
Application: HEX-Heat Exchangers
Substrate: Carbon steel
Products: Belzona 1121 (Super XL-Metal), Belzona 1331

Customer Location: Houston, TX
Application Date: November 2025

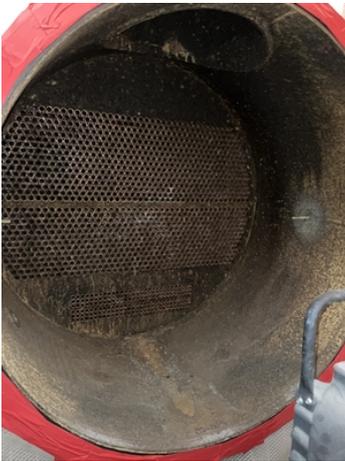
Condition of the asset before Belzona was applied.

The building this work was done at is the global HQ for a large company in Houston. The central plant chillers are used to help provide AC for the multiple buildings across the campus. The assets are costly and critical for the business, especially with the weather in Houston. For a customer with seven corroding chillers, full replacement means high costs and disruptions; Belzona's epoxy coatings rebuild damage, add a tough barrier against further corrosion, extend lifespan, cut maintenance, and maintain operations with little interruption.

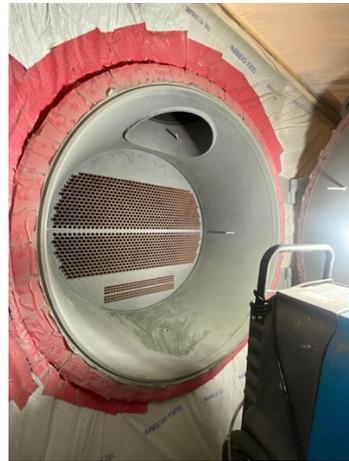
After the abrasive blasting was completed, SSPC-SP10.

1. The asset was opened, drained and dried using fans.
2. A containment was built by screwing together a wood frame and taping sheets of poly around it, to make an air tight enclosure.
3. Corks were used to plug the tubes.
4. Abrasive blasting was completed to achieve a minimum 3mil profile, SSPC-SP10.
5. Belzona 1121 was used to pit fill as needed.
6. Belzona 1331 was applied in a two coat system over the entire application area.

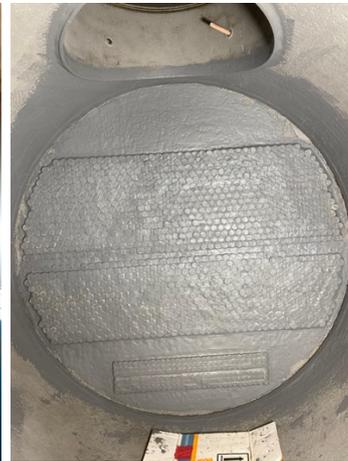
After Belzona 1121 was used to pit fill the tube sheet.
