# Repair of Ship Deck Using Belzona

ID: 10100

Application: *SOS-Ships and Offshore Structures*

Customer Location: *Dammam, Saudi Arabia*

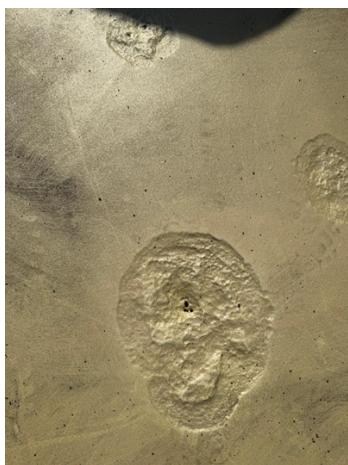
*A routine inspection revealed that the steel deck had suffered from heavy corrosion, resulting in noticeable metal loss and the formation of multiple pinholes. This level of deterioration posed a threat to the deck's operational reliability, highlighting the need for an effective and long-lasting repair solution.*

Evident pinhole damage on steel deck

Belzona 1111 (Super Metal) was then mixed and applied to rebuild the corroded sections and reinstate the deck to its original geometry. The material was worked and feathered to blend smoothly with the surrounding steel, restoring surface integrity, encapsulating the previously visible corrosion patterns, and protecting the rebuilt areas against future corrosion.

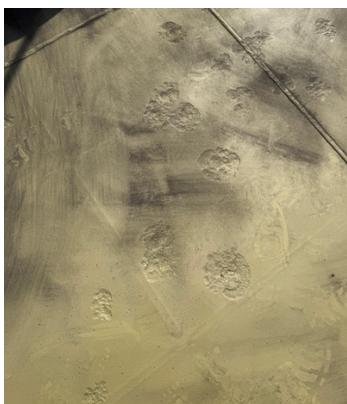
Multiple damaged locations on the steel deck

During inspection of the vessel's monkey island (upper deck), several areas of the steel deck were found to have recurring corrosion patterns showing through despite recent painting. The client needed a fast, controlled repair that avoided hot work and heavy equipment. Conventional grit blasting was not feasible due to the location and operational constraints, so a cold-work solution was required to restore the deck and its profile.

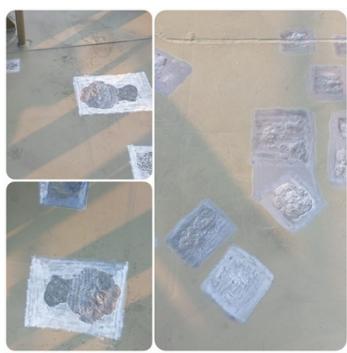
After surface preparation to SSPC-SP11

Surface preparation was completed using a rotary power tool to achieve an SSPC-SP 11 Power Tool Cleaning to Bare Metal standard. This produced a clean and consistent anchor profile suitable for rebuilding with Belzona. All surfaces were then cleaned using a residue-free solvent to remove contaminants and ensure proper adhesion.

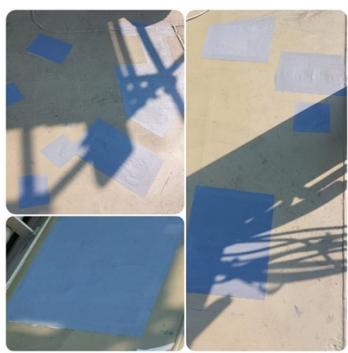
Completed Belzona application
