# Belzona Repairs Glass Lined Manway Cover during a Turnaround

ID: 10106

Application: VPF-Valves, Pipes and Fittings

Substrate: Carbon steel

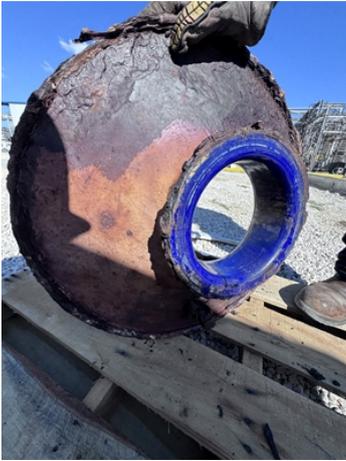
The customer has a large glass lined tank with a manway cover that experienced external corrosion from a leak dripping on it, and chipping to the glass lining at the sealing area. The neck of the nozzle experienced pitting and made it difficult to reattach the flange to create a proper seal. Also, the outer lip was almost gone due to corrosion, which created issues when trying to seal with clamp. They noticed this during a turnaround, so time was limited for a return to service for them to stay on schedule.

Before image of the manway cover

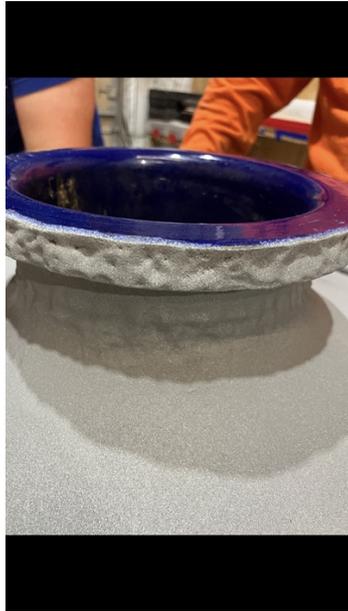
After abrasive blasting the externals, SSPC-SP10

1. Abrasive blasted the external of the manway cover, SSPC-SP10. Solvent wipe with Belzona 9111.
2. We hand sanded some of the glass lining at the sealing surface, so we can tie into with coating. We did not grit blast the glass.
3. Applied Belzona 1511 by stiff bristled brush & applicator to rebuild pitting and help create a smooth neck/nozzle for the flange to reattach.
4. Applied two coat system of Belzona 1593.
5. Customer applied UV resistant paint in the field.

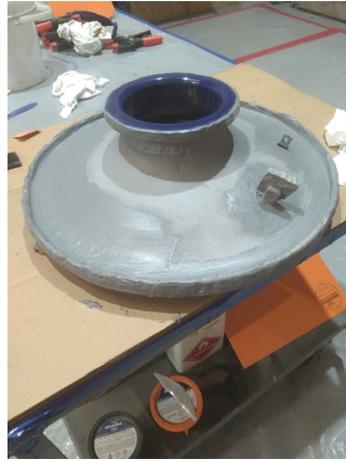
Rebuild with Belzona 1511 to create the proper lip around the circumference and rebuild pitting on the neck.

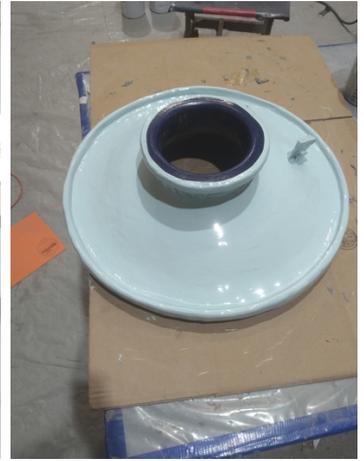
After Belzona 1593 was applied to provide corrosion protection
