# Concrete Leak Seal in Hospital Parking Garage Causing Grease Leakage onto Physician's Vehicle

ID: 10107

Application: WPA-Wall Problem Areas

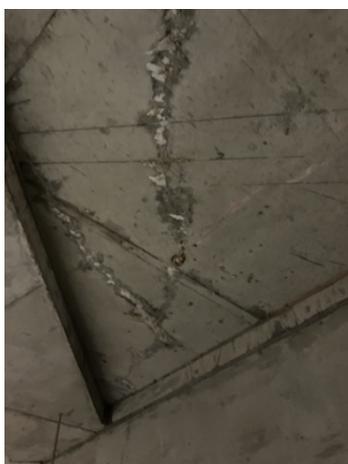
In the prominent medical center of Houston, TX, one Hospital facility has an underground parking garage below one of the building towers on their campus. The garage is used by everyone from patients to employees. One location in the garage, has a crack in the ceiling, that has grease dripping through it. It happened to fall right onto a Physicians vehicle in a reserved parking spot. This caused an issue between the Physician and Hospital, and needed immediate repair.

Long crack in the ceiling of the garage, before image.

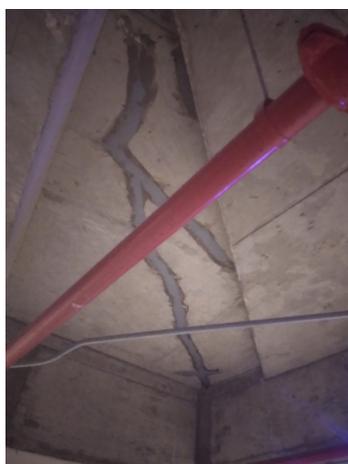
Belzona 9611 and 1212 used to composite patch crack and stop the active leak.

1. We hung sheets of poly and taped them to the ceiling & floor to create a containment. This protected cars in the garage and helped with cleanup.
2. We used a hand held grinder with 4.5" turbo cup diamond grinding bit to prep the concrete. The grinder had a dust collection attachment to help lower dust in the working area.
3. During prep, the slow dribble leak become more constant. Belzona 9611 was used to plug active leaks. Belzona 1212 was used to rebuild and seal.

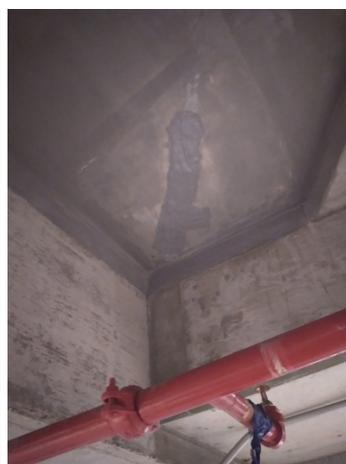
Belzona 3121 and 9331 applied to patch the crack and perimeter seams.

4. Belzona 3121 and 9331 were applied in 6" wide sheets to patch the cracks and joint at the perimeter of the ceiling area.
5. Belzona 3121 and 9331 were applied onto the entire ceiling area.

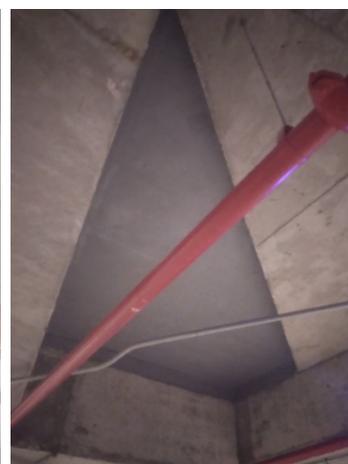
Entire ceiling area sealed with Belzona 3121 and 9331
