Concrete Leak Seal in Hospital Parking Garage Causing Grease Leakage onto Physician's Vehicle

ID: 10107

Application: WPA-Wall Problem Areas

Substrate: Concrete

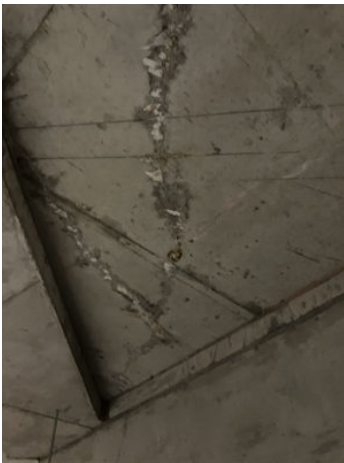
In the prominent medical center of Houston, TX, one Hospital facility has an underground parking garage below one of the building towers on their campus. The garage is used by everyone from patients to employees. One location in the garage, has a crack in the ceiling, that has grease dripping through it. It happened to fall right onto a Physicians vehicle in a reserved parking spot. This caused an issue between the Physician and Hospital, and needed immediate repair.

Long crack in the ceiling of the garage, before image.

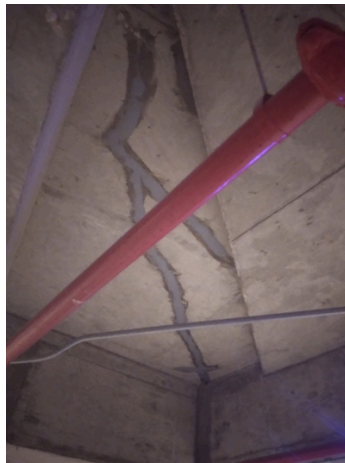
Belzona 9611 and 1212 used to composite patch crack and stop the active leak.

1. We hung sheets of poly and taped them to the ceiling & floor to create a containment. This protected cars in the garage and helped with cleanup.
2. We used a hand held grinder with 4.5" turbo cup diamond grinding bit to prep the concrete. The grinder had a dust collection attachment to help lower dust in the working area.
3. During prep, the slow dribble leak become more constant. Belzona 9611 was used to plug active leaks. Belzona 1212 was used to rebuild and seal.

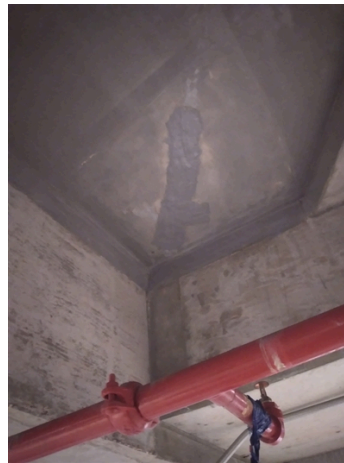
Belzona 3121 and 9331 applied to patch the crack and perimeter seams.

4. Belzona 3121 and 9331 were applied in 6" wide sheets to patch the cracks and joint at the perimeter of the ceiling area.
5. Belzona 3121 and 9331 were applied onto the entire ceiling area.

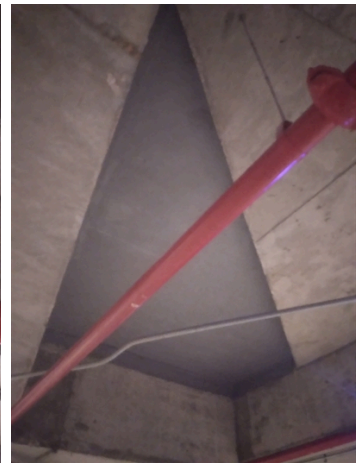
Entire ceiling area sealed with Belzona 3121 and 9331
