Ramps and Landings with Belzona 4151

Application: FPA-Floor Problem Areas

Substrate: Concrete

Products: Belzona 4151 (Magma-Quartz Resin), Belzona 4911 (Magma TX Conditioner)

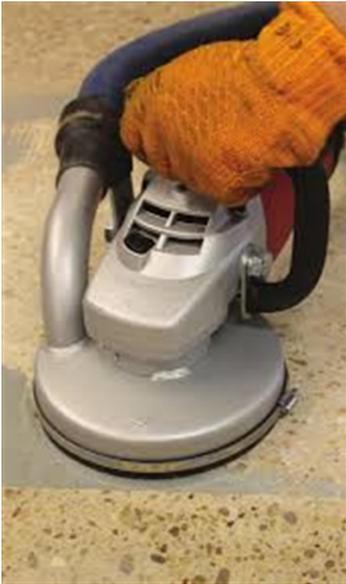
We first cleaned and prepared the concrete using surface grinders.

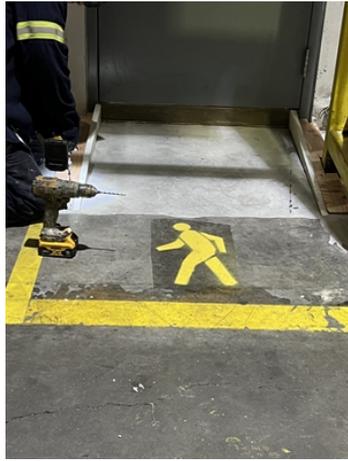
Next we built the forms to contain the Belzona 4151 with added aggregate to create a smooth edge and proper height.

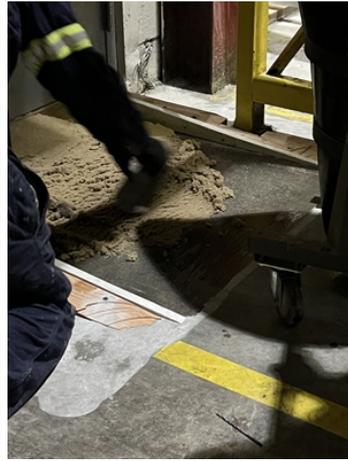
Then we mixed the aggregate with the Belzona 4151 to the consistency recommended to create a flowable but firm mixture.

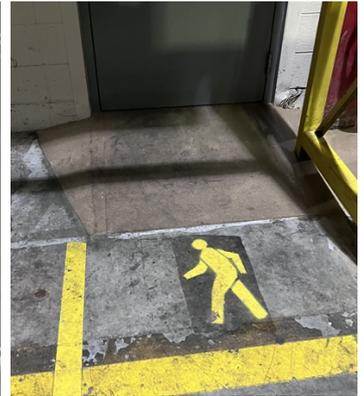
To finish, we removed the forms after the recommended cure time and opened the doorway back up to pedestrian traffic.
