BELZONA PROTECTS DIFFUSER VANES

ID: 1011

Industry: Power
Application: CEP-Centrifugal Pumps
Substrate: Steel
Products: * Belzona® 1321 (Ceramic S Metal) ,
* Belzona® 1121 (Super XL Metal) ,

Customer Location: Irrigation District- Wyoming, USA
Application Date: January 2008

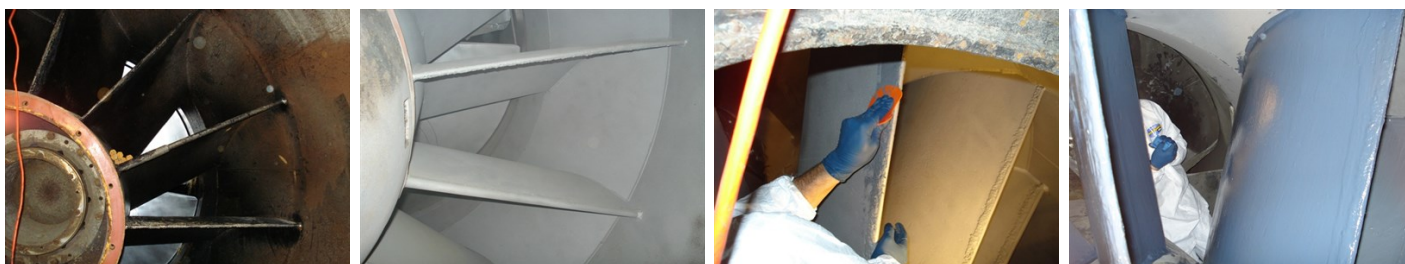
Photograph Descriptions

The diffuser vanes were suffering from erosion/corrosion. Previous attempts were made to protect them using coal tar epoxies with limited success.

- * Diffuser vanes before blasting ,
- * Diffuser vanes after blasting ,
- * Belzona® 1121 applied to smooth edges ,
- * Second coat of Belzona® 1321 applied ,

Application was carried out in accordance with Belzona System Leaflets CEP-3 and CEP-5. Belzona® 1121 was used to smooth out the edges of the vanes to rebuild metal loss. Belzona® 1321 was applied by stiff bristled brush to protect against further erosion/corrosion.
