# Wear Resistance Cold Bond Plating

ID: 10110

Industry: *Mining & Quarrying*  
 Application: *SHM-Solids Handling Machinery*

Substrate: *Carbon steel*  
 Products: *Belzona 1111 (Super Metal), Belzona 1812 (Ceramic Carbide FP)*

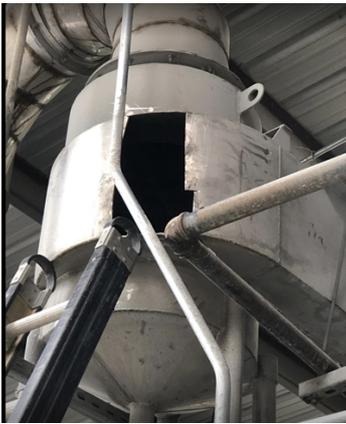
*This small cyclone was faced with years of wear from the material this plant produces. This facility produces the granules that sandpaper and grinding wheels are made from.*

The first picture is where the granules had eaten away the surface of the cyclone. We had to cut it out to make it a better sealing surface.

We used grinders to cut away the jagged edges and to create a smooth edge. Then we used the MBX Bristle Blaster to prepare the surface for adhesion. We applied Belzona 1111 and 1812 with Belzona supplied knife and applicator pad.
