Propeller Repair & Coating

ID: 10111

Application: CEP-Centrifugal Pumps

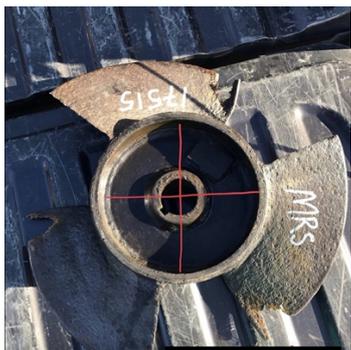
This propeller had seen years of pumping water out of a slough due to high water during rain or Beaver dams backing the water up. The propeller had seen water, tree limbs and rock that caused the damage.

This picture is of the damaged propeller.
