Repair and Protection of Main Condenser-Coal Plant

ID: 10112

Application: HEX-Heat Exchangers

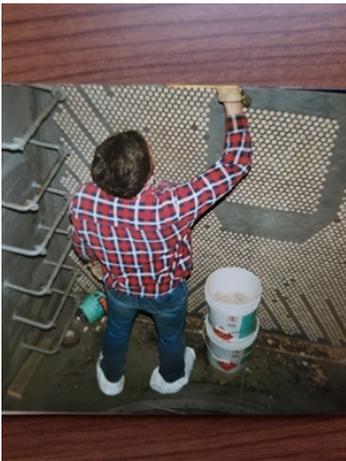
Swanson Youngdale applying corks in tubes.

Tubes were corked (over 2000) and then face was blasted, once blasted the tubes were corked again flush; Belzona 1121 metal was trolled in the bring face flush with tubes. As per Instructions for Use, Belzona 1321 was applied in 2 coat system.

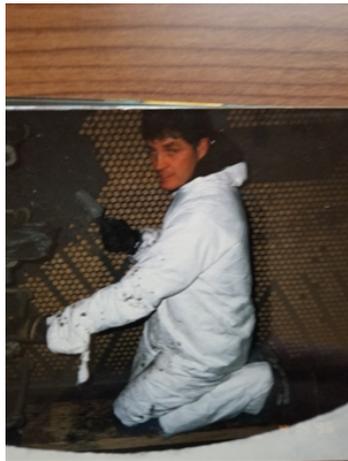
Contractor applying Belzona 1121 between all tubes; bring it flush with tubes

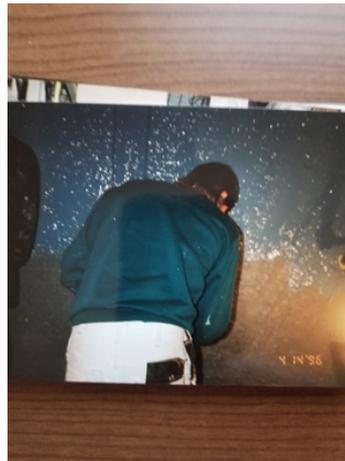
Application of 2 coats of Belzona 1321
