Repair and Protection of Main Condenser-Coal Plant

Industry: *Power*Customer Location: *Underwood, North Dakota*Application: *HEX-Heat Exchangers*Application Date: *March 1996*Substrate: *Carbon steel*Products: *Belzona 1121 (Super XL-Metal), Belzona 1321 (Ceramic S-Metal)*

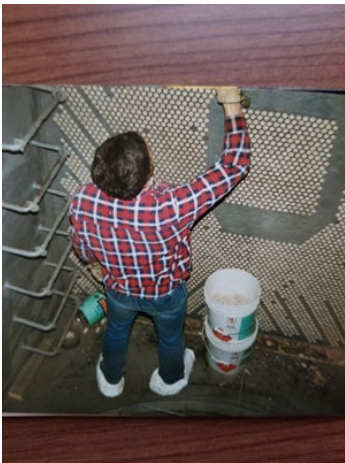
Swanson Youngdale applying corks in tubes.

Tubes were corked (over 2000) and then face was blasted, once blasted the tubes were corked again flush; Belzona 1121 metal was trolled in the bring face flush with tubes. As per Instructions for Use, Belzona 1321 was applied in 2 coat system.

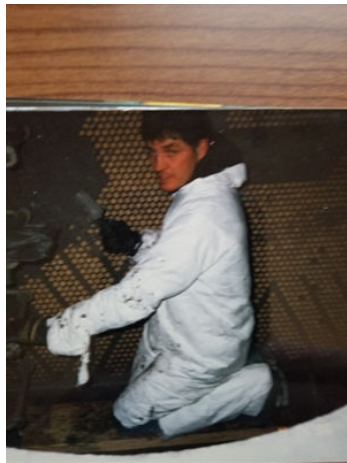
Contractor applying Belzona 1121 between all tubes; bring it flush with tubes

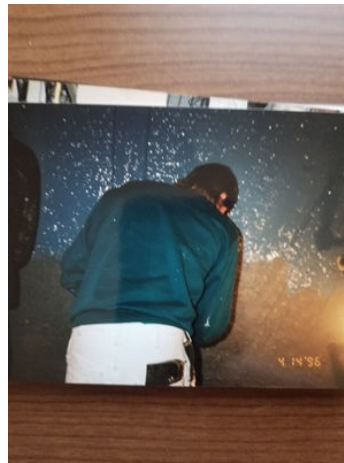
Application of 2 coats of Belzona 1321
