# Main Condenser Expansion Joint Saved

ID: 10115

Industry: *Power*

Application: *WPA-Wall Problem Areas*

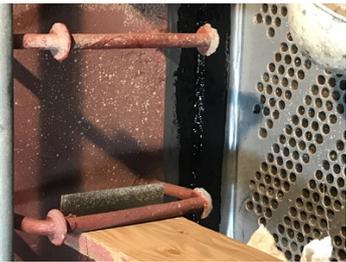
Closeup of Belzona 2111 elastomer expansion joint in main condenser

The joint area was blasted and cleaned, Belzona 2911 was applied on entire surface area, and the Belzona 2111 reinforced system application was carried out during outage.

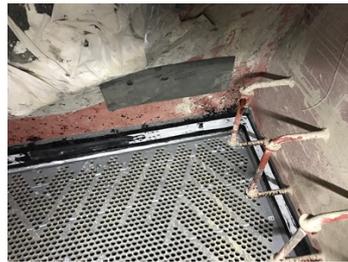
Belzona 2111 application reinforced with reinforcement mesh replacing expansion joint

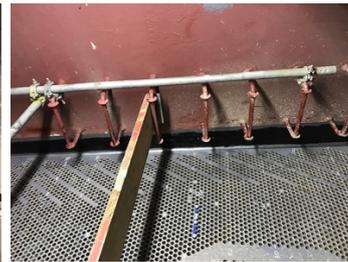
Close-up of final expansion joint using Belzona 2111 elastomer

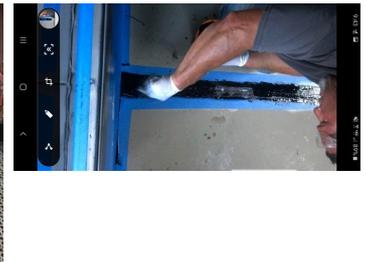
Belzona 2111 completed application
