Repair of Damaged Flanges Using the Belzona Flange Face Forming Technique

ID: 10116

Customer Location: Al Khafji, Saudi Arabia

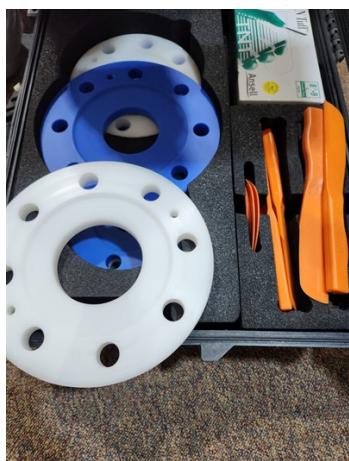
Belzona Flange Face Forming Kit

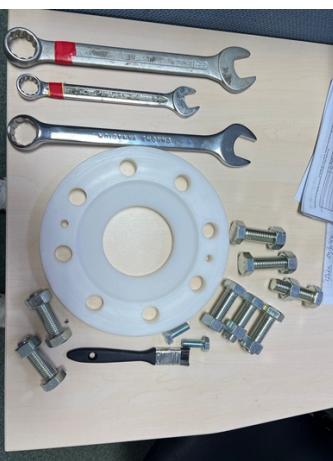
Flange Face Former and Accessories Required for the Repair

Belzona 9411 Release Agent was applied to the flange forming kit to allow smooth demoulding after cure. Belzona 1511 (Super HT-Metal) was mixed and applied to both the prepared flange surfaces and the former. Using the pre-cut applicator, a central sealing peak was created to replicate the correct gasket seating surface geometry.

The Belzona flange formers were installed, tightened, and left to cure. Once fully cured, the bolts were removed, the formers dismantled, and the restored flange faces were ready to be returned to service.

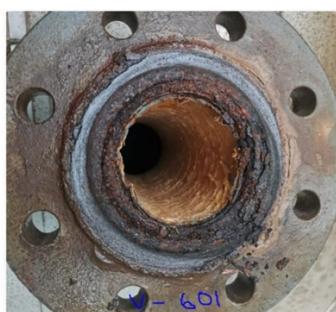
Two critical process vessels handling crude oil and produced water were experiencing severe corrosion on multiple flange faces due to the presence of H₂S in the system. The corrosion progressed rapidly, resulting in significant deterioration of the flange faces and subsequent leakage. These leaks disrupted normal plant operations, leading to unplanned downtime and production losses. Immediate action was required to restore sealing integrity and return both vessels to service.

Defective Flanges

The damaged flange faces were first grit blasted to achieve a minimum surface profile of 75 microns and Sa 2.5 cleanliness. Belzona 9111 Cleaner/Degreaser was then used to remove any remaining contamination and ensure full substrate cleanliness.

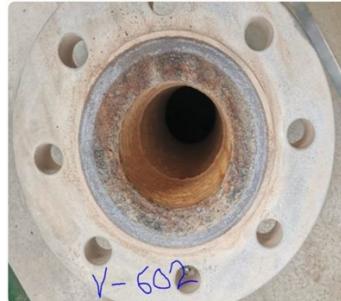
Flange Faces After Belzona Repair

The Belzona Repair Kit proved to be a highly effective and time-saving solution for the customer. The use of Belzona 1511 (Super HT-Metal) enabled the restoration of serrated sealing faces, eliminating the need for hot work, flange replacement, or extended shutdown.
