Restoration of Severely Corroded Chiller Components with Belzona

ID: 10119

Industry: Heating, Ventilation & Air Conditioning
Application: HEX-Heat Exchangers
Substrate: Carbon steel
Products: Belzona 1121 (Super XL-Metal), Belzona 1321 (Ceramic S-Metal)

Customer Location: Orlando, Florida
Application Date: December 2025

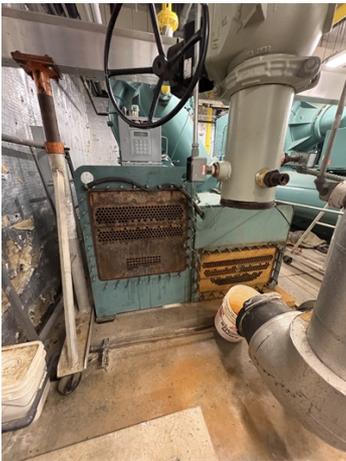
The initial condition of the heat exchanger access covers is shown prior to repair. The surfaces exhibit severe corrosion, material loss, and deterioration around the tube sheet, resulting in leaks and unsafe operating conditions.

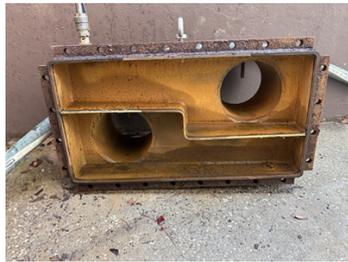
Interior of the chiller water box section after removal, showing severe rust, coating failure, and subsurface corrosion across internal surfaces, especially around flow paths and flange edges. The lining had lost adhesion and exposed the steel.
