# Belzona 1341 Ensures Reliable Heat Exchanger Performance During a Major Turnaround

ID: 10120

Industry: Chemical & Petrochemical  
Application: HEX-Heat Exchangers  
Substrate: Carbon steel  
Products: Belzona 1111 (Super Metal), Belzona 1341 (Supermetalglide), Belzona 9111 (Cleaner Degreaser)

Customer Location: Saudi Arabia  
Application Date: May 2025

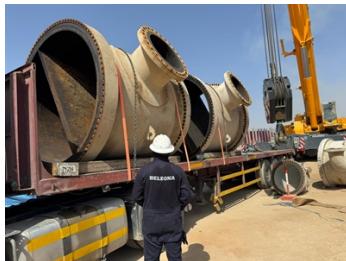
General Overview of the Cooling Water Channel Heads

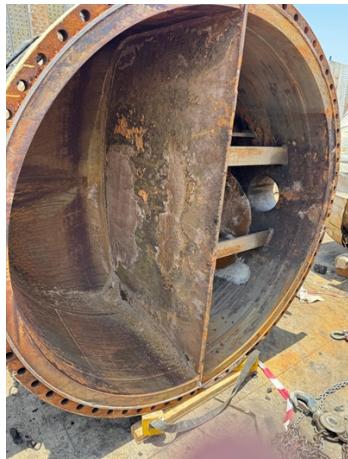
The customer was experiencing corrosion and erosion on the channel heads of cooling water heat exchangers. Over time, this resulted in metal loss, pitting, and surface deterioration, compromising the integrity of the equipment, increasing the risk of leakage, and reducing overall heat transfer efficiency.

A heat exchanger channel head in a petrochemical plant had suffered significant corrosion-erosion, resulting in wall-thickness loss.

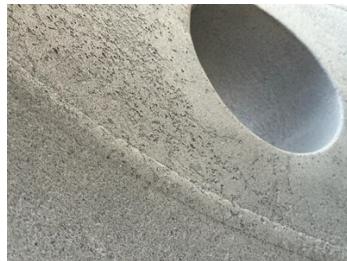
After Grit Blasting Surface Preparation

- Surface preparation was performed by grit blasting to achieve the required surface profile, followed by thorough cleaning with Belzona 9111 (Cleaner Degreaser).

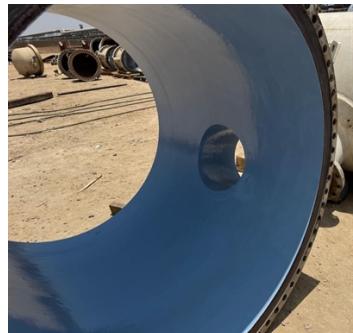
Completed application of Belzona 1341 (Supermetalglide) on the heat exchanger channel head.

- Belzona 1111 (Super Metal) was then applied to rebuild the damaged areas.
- Belzona 1341 (Supermetalglide) was subsequently applied to provide a smooth, corrosion-resistant protective coating.
