Secondary Chemical Containment

ID: 10121

Industry: Chemical & Petrochemical
Application: TCC-Tanks and Chemical Containment Areas
Substrate: Concrete
Products: Belzona 4111 (Magma-Quartz), Belzona 4311 (Magma CR1), Belzona 4911 (Magma TX Conditioner)

Customer Location: Decatur, AL
Application Date: November 2021

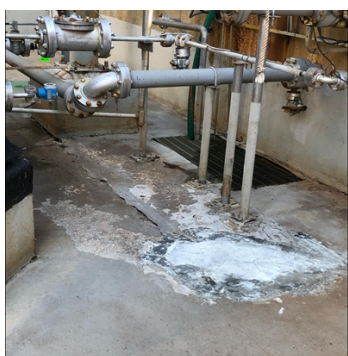
This secondary chemical containment had never been coated and has seen several spills over the last few years. This has caused severe damage to the concrete and sump pit area where water/chemicals had stood until it was pumped out.

Before picture of the containment area where you can see the damaged areas.

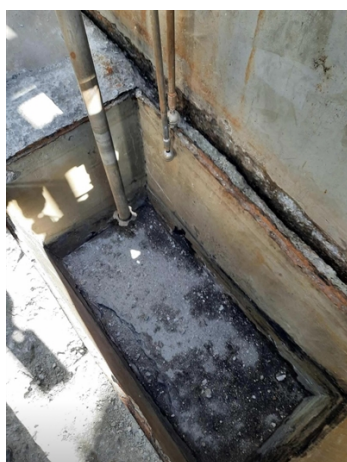
Close up of the sump pit area. Here you can see how bad the concrete had deteriorated between the sump pit and exterior wall of the containment.
