Secondary Chemical Containment

ID: 10121

Application: TCC-Tanks and Chemical Containment Areas

Products: Belzona 4111 (Magma-Quartz), Belzona 4311 (Magma CR1), Belzona 4911 (Magma TX Conditioner)

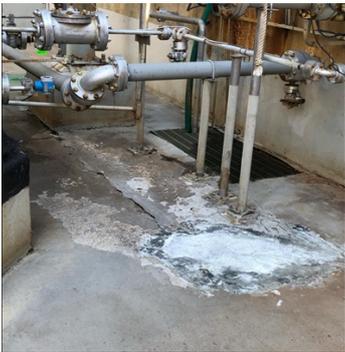
This secondary chemical containment had never been coated and has seen several spills over the last few years. This has caused severe damage to the concrete and sump pit area where water/chemicals had stood until it was pumped out.

Before picture of the containment area where you can see the damaged areas.

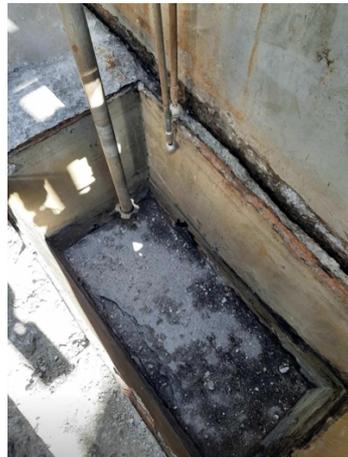
Close up of the sump pit area. Here you can see how bad the concrete had deteriorated between the sump pit and exterior wall of the containment.

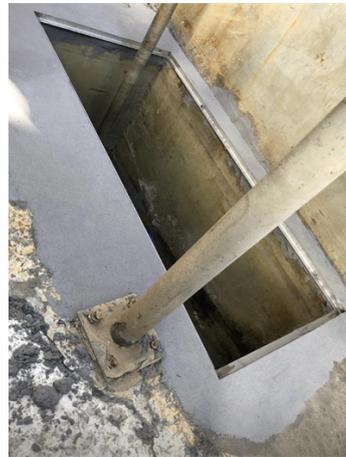
In this picture, after we removed all loose and damaged concrete we thoroughly cleaned the area to be repaired with 100% MEK and began to prep the surface with grinders and needle guns. Once we achieved the correct surface prep we applied Belzona 4111

In this project we used several types of equipment such as walk behind grinders, hand held grinders and needle guns to prepare the

surface. We also used speciality designed trowels to contour the edges of the sump pit for the grating and the two inch cove around the bottom interior wall.

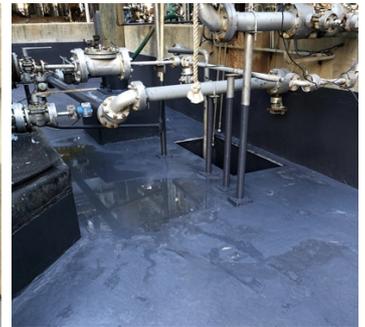
Once the repair was complete we applied 2 coat of Belzona 4311. In this application we perform a yearly inspection for the client.
