# VALVE BODY SUPER WRAP WITH BELZONA 1984

ID: 10129

Customer Location: FLORENCE, AL

Application: VPF-Valves, Pipes and Fittings

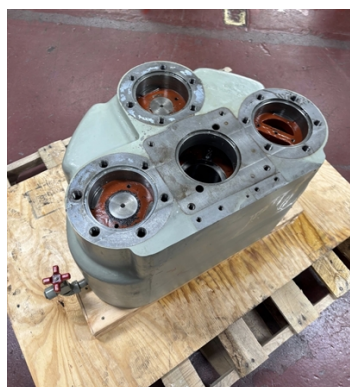
THE VALVE BODY RUNS AT OVER 1000 PSI AND UNDER YEARS OF STRESS CREATED A HAI LINE CRACK IN THE TOP OF THE VALVE BODY. THE ITEM IS OBSOLETE AND CAN NOT BE REPLACE EASILY.

THIS PHOTO IS BEFORE WE MADE ANY REPAIRS TO THE VALVE BODY.

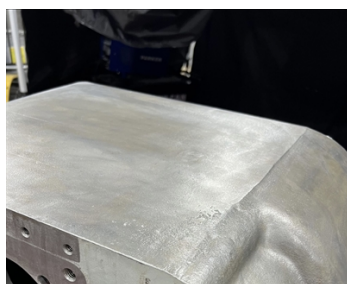
IN THIS PHOTO WE PREPPED THE SURFACE AREA USING MEK TO REMOVE ANY OILS FOLLOWED BY HEATING THE SURFACE AREA TO REMOVE ANY OILS THAT HAD BEEN ABSORBED IN THE METAL. FOLLOWED UP WITH A BRISTLE BLASTER FOR A 3MIL PROFILE.

THIS APPLICATION TOOK SEVERAL DAYS TO COMPLETE. WE PLANNED FOR THIS PROJECT FOR ALMOST A MONTH BEFORE STARTING THE REPAIR PROCESS. ONCE WE STARTED WE FIRST BEGAN BY USING MEK TO REMOVE OILS, DIRT AND DEBRIS FROM THE SURFACE. FOLLOWED BY HEATING THE SURFACE AREA TO SWEAT OUT ANY REMAINING OILS THAT HAD BEEN ABSORBED IN THE METAL. THEN WE USED A BRISTLE BLASTER TO ACHIEVE A 3 MIL SURFACE PROFILE. THEN WE MADE A COLD BOND PLATE USING BELZONA 1161. THEN APPLYING SIX BELZONA SUPER WRAPS USING 1984 TO ENCAPSULATE THE ENTIRE VALVE BODY.

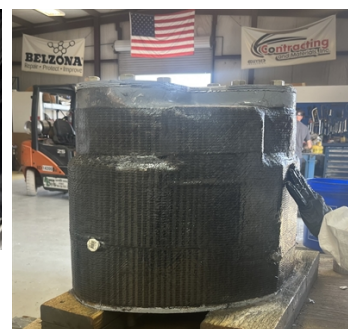
FINAL PHOTO SHOWS HOW WE WRAPPED THE ENTIRE VALVE BODY USING BELZONA 1984 AND CARBON FIBER SUPER WRAP. WE APPLIED 6 WRAPS TO THIS APPLICATION FOLLOWED BY BELZONA 9382 RELEASE FILM TO COMPRESS THE WRAPS AND 1984.
