Belzona 1111 & 5815 Repairs and Protects Fiberglass Tank at Chemical Plant

Industry: Chemical & Petrochemical
Application: TCC-Tanks and Chemical Containment Areas
Substrate: Other
Products: Belzona 1111 (Super Metal), Belzona 5815

Customer Location: Sylacauga, Alabama
Application Date: September 2025

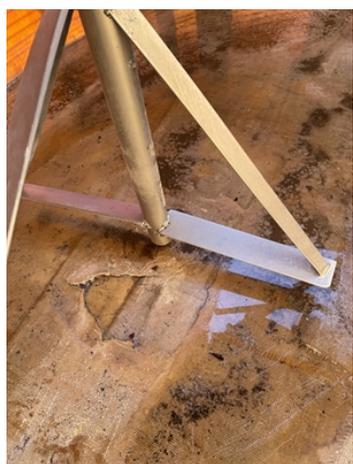
Our client's fiberglass tank had a few small hairline cracks where the chemical aluminum sulfate would seep out. They had an inspection report done and it was found they needed repairs.

Worn damaged fiberglass area

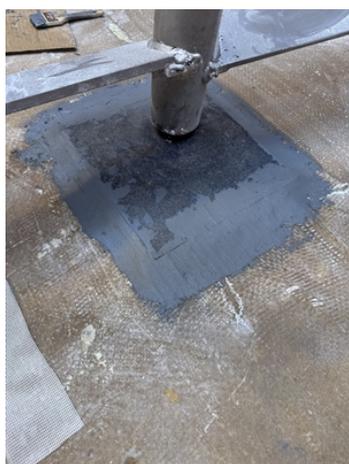
Belzona 1111 with Reinforcement Cloth shown over a cold plate bond on floor of fiberglass tank

First, the areas for repair were sandblasted for a roughened profile. We then sanded and grinded areas that were chipping or needed to be feathered in. Belzona 1111 was applied with reinforcement cloth to areas that were thin and in some areas we did a cold plate bond over any voids. We then overlaid those areas and tank seams with Belzona 5815 and composite reinforcement cloth.

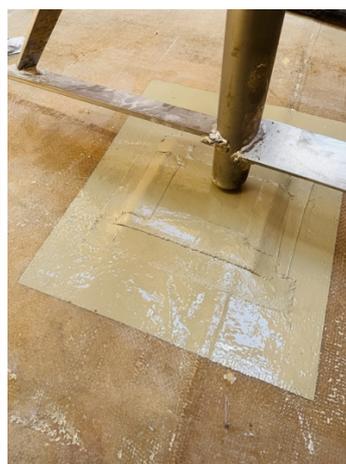
Belzona 5815 and Composite Reinforcement Wrap Overlay on 1111 Repaired Areas

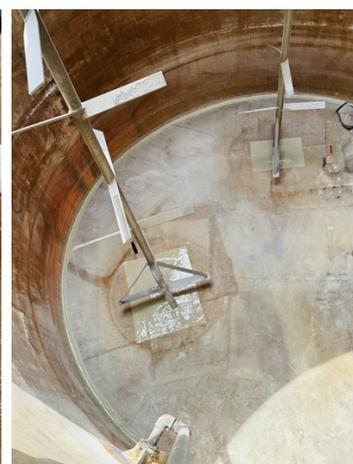
Aerial view of 5815 repairs in tank
