Belzona 1111 & 5815 Repairs and Protects Fiberglass Tank at Chemical Plant

ID: 10130

Industry: Chemical & Petrochemical
Application: TCC-Tanks and Chemical Containment Areas
Substrate: Other
Products: Belzona 1111 (Super Metal), Belzona 5815

Customer Location: Sylacauga, Alabama
Application Date: September 2025

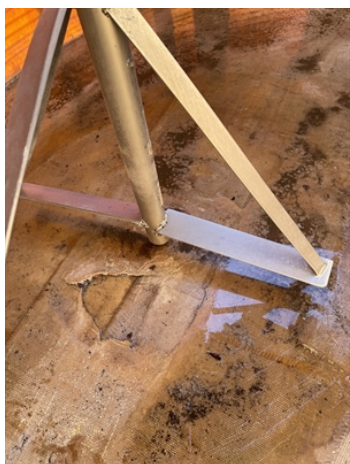
Our client's fiberglass tank had a few small hairline cracks where the chemical aluminum sulfate would seep out. They had an inspection report done and it was found they needed repairs.

Worn damaged fiberglass area

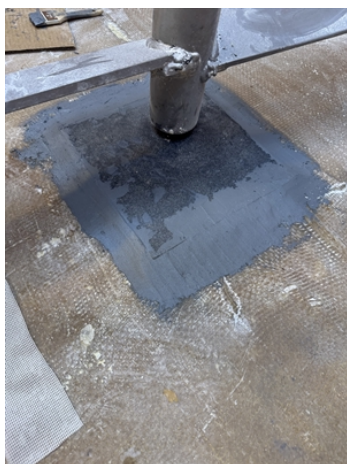
Belzona 1111 with Reinforcement Cloth shown over a cold plate bond on floor of fiberglass tank

First, the areas for repair were sandblasted for a roughened profile. We then sanded and grinded areas that were chipping or needed to be feathered in. Belzona 1111 was applied with reinforcement cloth to areas that were thin and in some areas we did a cold plate bond over any voids. We then overlaid those areas and tank seams with Belzona 5815 and composite reinforcement cloth.

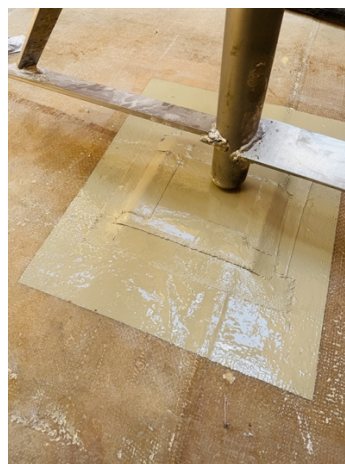
Belzona 5815 and Composite Reinforcement Wrap Overlay on 1111 Repaired Areas

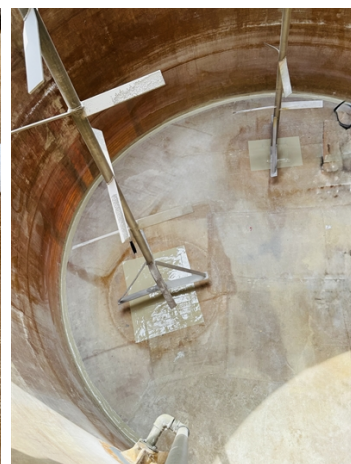
Aerial view of 5815 repairs in tank
