Secondary Containment Repair & Coating

ID: 10134

Application: TCC-Tanks and Chemical Containment Areas

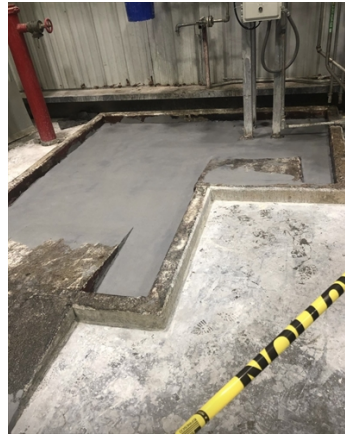
The client was facing deteriorating concrete due to chemical spillage when replacing the chemical storage container.

You can see the damaged concrete areas in this picture from the chemical spillage.

We had to make a few deeper concrete repairs using Belzona 4111 before moving forward.

Once the other areas had been repaired we skimmed most of the containment area to bring back to level using Belzona 4111

We first began by neutralizing the affected area. Then we began to remove loose and damaged concrete with needle guns and hand grinders. Once the damaged areas were prepped we began to apply Belzona 4911 Conditioner followed by Belzona 4111 to fill pockets of damaged areas followed by skimming the containment area to level the floor and for proper drain. Next we applied two coats of Belzona 4311 to the containment and curbing and providing a little extra protection by carrying the coating over the curbing and ramp.

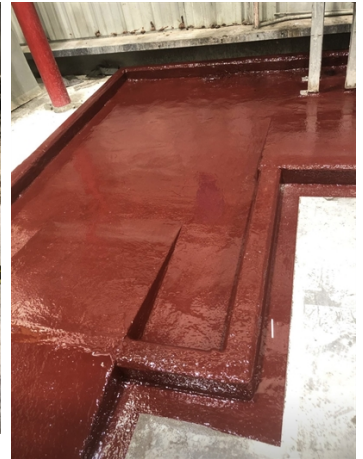
Here you can see the completed application using Belzona 4311 due to high concentration of chemical.
